# CASE HISTORY

## THE RESTORATION AND STABILISATION OF THE BLISTS HILL FURNACES, TELFORD, ENGLAND, U.K.

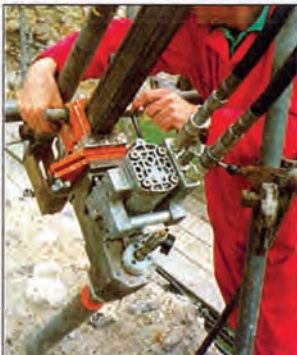
Drilling

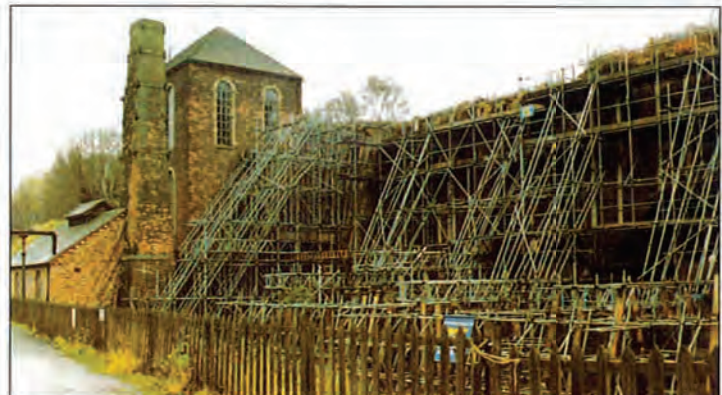
Restoration work in progress

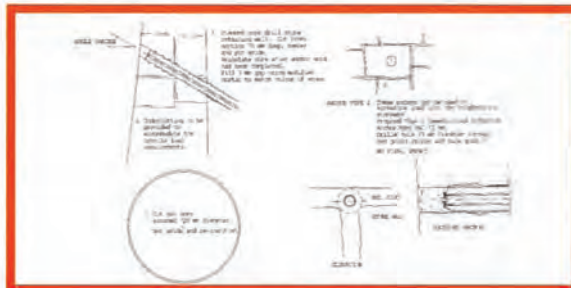
Making good anchor holes in stonework

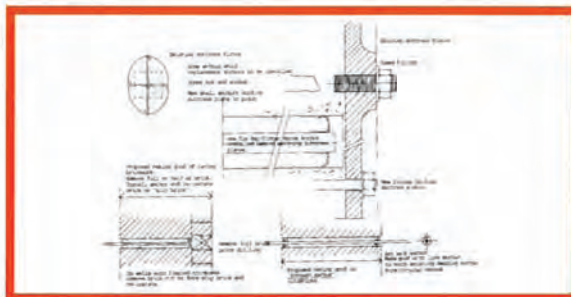
Making good anchor holes in brickwork

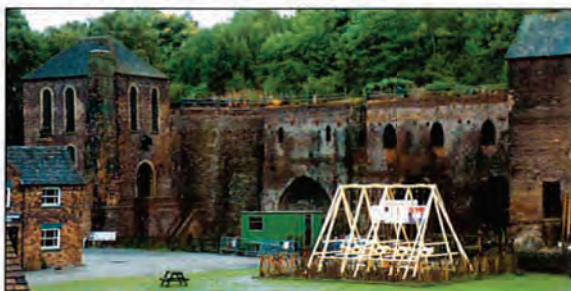
Completed renovation
