# CASE HISTORY

## WORCESTER VIADUCT

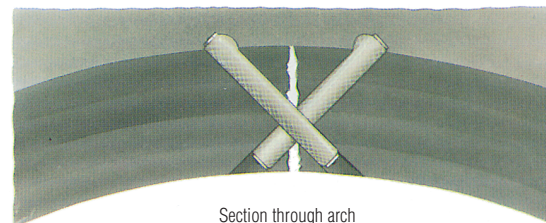
Section through arch

Worcester Viaduct comprises sixty-five brickwork arches rising from approximately two storey height near the railway station to over three storey height as it approaches the river. Lack of proper draining within the arch had led to the spandrel walls being forced away from the intrados arch with longitudinal cracks close to the longitudinal edges of the bridge. Water penetration had contributed to cracking at the springings of some spans and delamination of external parts of some columns. These problems had been exacerbated by weathering, particularly freezing and thawing. Previous efforts to restore the structural integrity were evident, but had proved ineffective.

Transverse 30 x 30 x 3 SHS stainless steel WSA anchors were installed to restore the integrity of the spandrel wall/intrados arch connection at approximately 750mm centre-to-centre and alternate lengths of 2.0m and 2.5m. Stitching anchors were angled across the longitudinal cracks to restore structural integrity and the cracks were then filled. Transverse and diagonal stitching anchors, type RWT, 15 x 15 x 1.5 SHS stainless steel, were installed to restore the strength of the delaminated columns and the cracks filled. Drainage holes were drilled through the intrados and plastic pipes were installed to help relieve the existing water pressure. To date five spans have been renovated using the Cintec system and further spans will be renovated as part of an ongoing maintenance programme.
