# CASE HISTORY

## CASTLE WARD HOUSE, NORTHERN IRELAND, U.K.

Castle Ward House is situated near Strangford, Northern Ireland. The property was constructed in 1756.

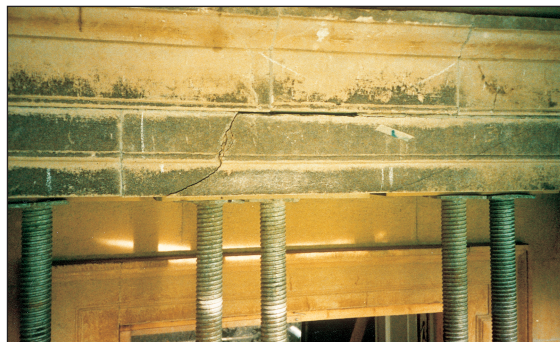
An inspection during the course of repairs revealed that one of the original timber beams in the area of the Tympanum had seriously decayed. This beam acted as a support for the upper stonework and a hanger for the lower stones. With this decay the lower stones had cracked and showed signs of falling out.

First sign of distressed beam

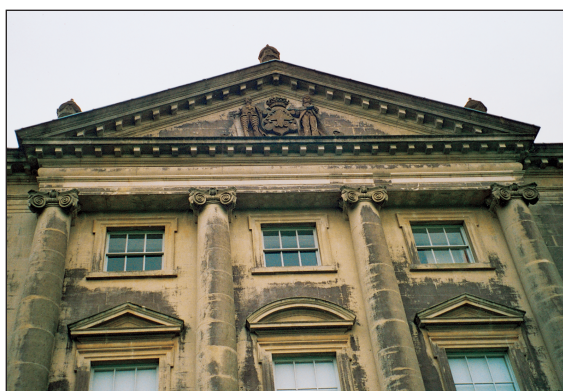
External upper beam area

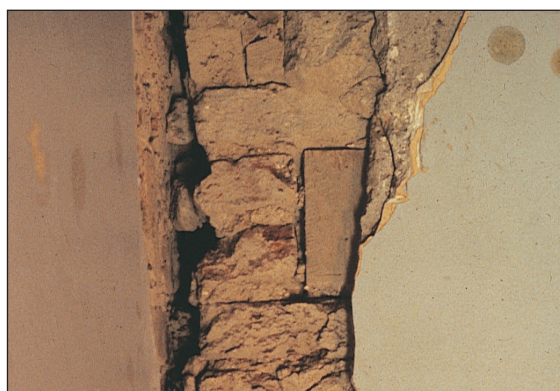
Internal damage of wooden beam

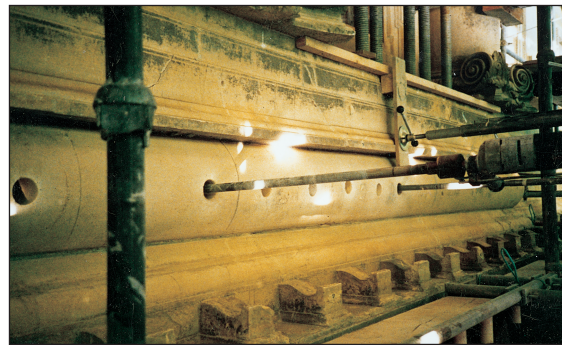
Drilling & securing stonework above beam

Because of the failure of the beam the immediate problem of support was solved by using 15 x 15 x 1000 mm SHS stainless steel anchors both horizontally and vertically.

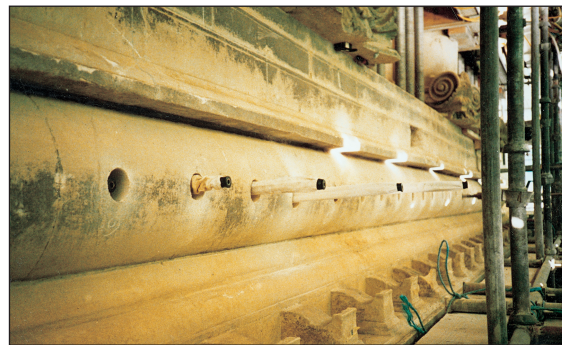
Anchor installation

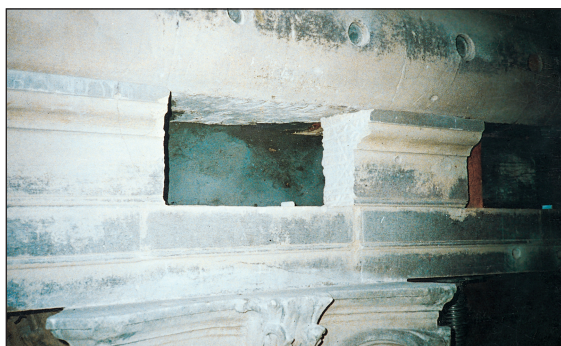
Openings cut in masonry to expose defective wooden beam prior to its removal

Once these anchors were installed the remains of the beam were removed and the problem of replacing it was addressed.

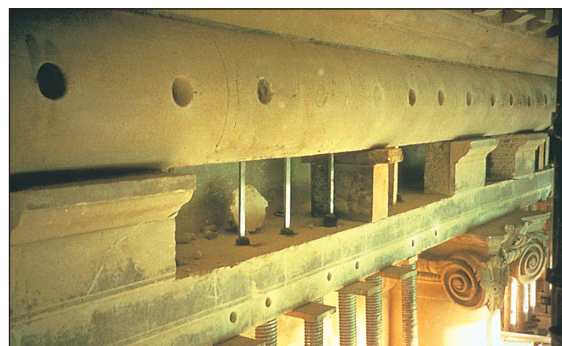
Entire length of 10 metres exposed

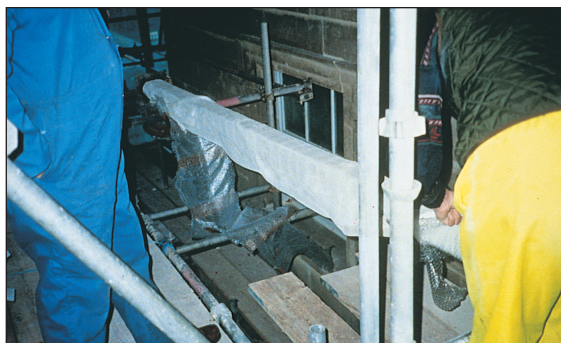
Insitu assembly of 100 x 100 mm stainless steel 10 m anchor

These beams were constructed of 100 mm x 100mm stainless steel box sections shrouded in a 300 mm sock, with an outer sock for protection. These beams were slid into position and shuttering was installed to prevent grout overhang. 300 kgs of grout were pumped between the sock and the exterior of the beam to form a perfectly contoured support.

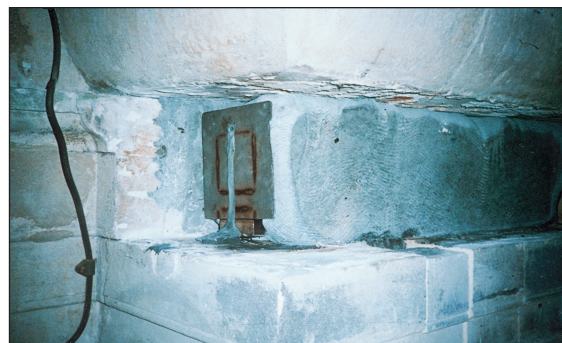
Beam after grout injection
