## Astley Castle, Warwickshire

## ASTLEY CASTLE – STRUCTURAL REPAIRS SCHEDULE 01 – option 1 (Rev A)

### North End of East Elevation – Proposed

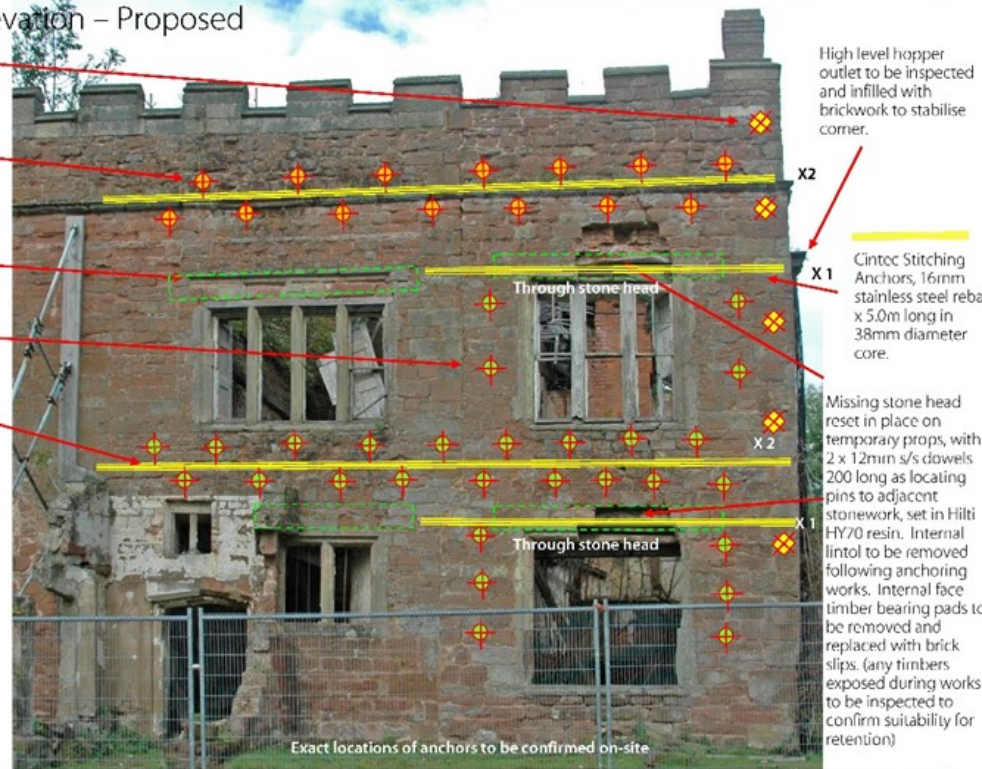
Given the extreme decay and degradation of the masonry this structure was a real challenge. The elements and vegetative growth had taken its toll on the “earth” lime mortar with many areas of missing and loose stones. The main external walls were strengthened longitudinally over the openings and the separating leaves of the wall tied together with consolidation anchors.

Cintec RWT 15 Consolidation Anchors 1200mm long, min 600mm into masonry return.

Cintec 10mm RAC Consolidation Ties, in 25mm diameter hole, 1 length to suit wall, (allow 400mm).

Existing timbers replaced with like-for-like Oak lintol, air dried to approx 12% moisture content. (See Detail A)

Cintec 10mm RAC Consolidation Ties, 550 Long in 25mm diameter hole

Cintec Stitching Anchors in pairs, 16mm stainless steel rebar x 9.5m long in 38mm diameter core, (See Detail B)
