# CASE HISTORY

## WALL TIE REPLACEMENT, CARDIFF

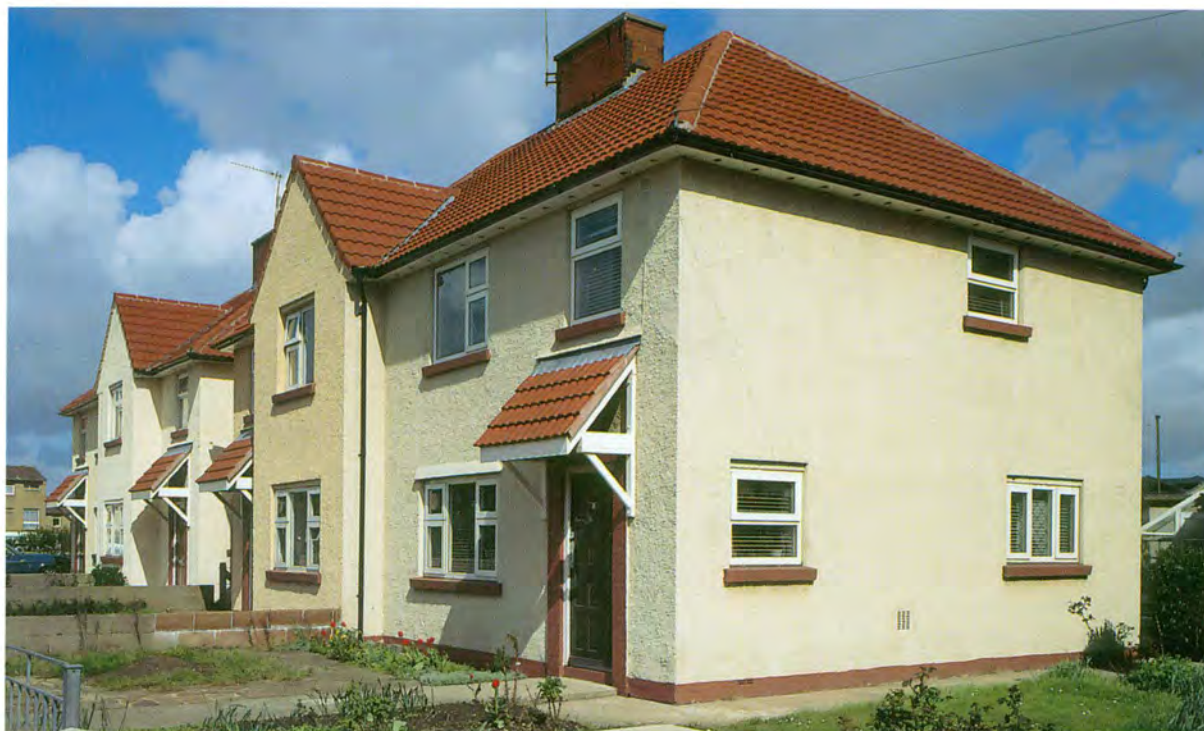
The photograph of a typical house in Butetown, Cardiff is typical of the use of Cintec RAD anchors. In Cardiff, over 500,000 RAD anchors have been installed in the housing stock, thus securing the continued life of the housing and removing the problems associated with corrosion of zinc-coated galvanised steel wall ties.

The existing ties were located using a metal detector. They were over-drilled using a 60mm diameter over-coring drill and removed. The 60mm diameter Cintec RAD anchor was installed based on 10 x 1mm CHS stainless steel section with socks at either end in the external and internal walls. Grout was injected under pressure and the external skin was made good to match the existing brickwork.
