# CASE HISTORY

## GEOFFREY HARRIS HOUSE, CROYDON, ENGLAND, U.K.

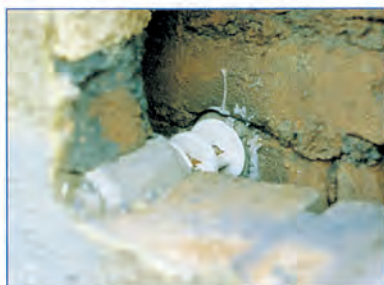
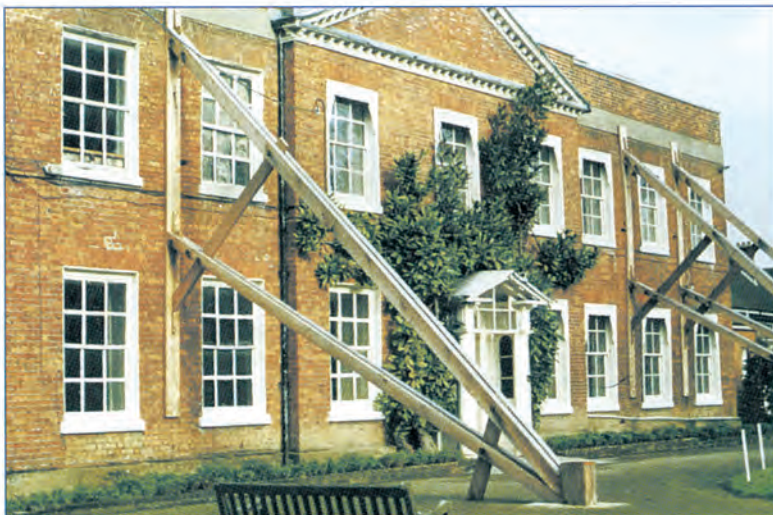
The front elevation of the building itself presented great problems. The facing wall comprised a thin 100 mm skin built without foundations. Of late Victorian age, it was out of plane, cracked and severely out of plumb. Originally built in a straight line, the cavity between the facing wall and the main wall varied from 10 - 75 mm. There are no ties or connection, except for odd pieces of timber.

Soldier arches were provided over the window openings and seen to be displaced or cracked. A survey of the facing wall revealed out of plumb dimensions of 100 to 150 mm. These variations occurred haphazardly over the whole area of the front elevation.

It was decided that the wall would have to be rebuilt. Concern at the instability of this wall was such that it was decided that, until the rebuilding could be carried out, heavy and well braced shores needed to be erected to avoid collapse. The main wall to which the facing wall was added, varied in thickness from 300 to 600 mm as piers, with infilling of solid brickwork, in general 300 mm thick.
