# CASE HISTORY

## MAGDALEN BRIDGE, OXFORD, ENGLAND, U.K.

## GEOFFREY HARRIS HOUSE, CROYDON, ENGLAND, U.K.

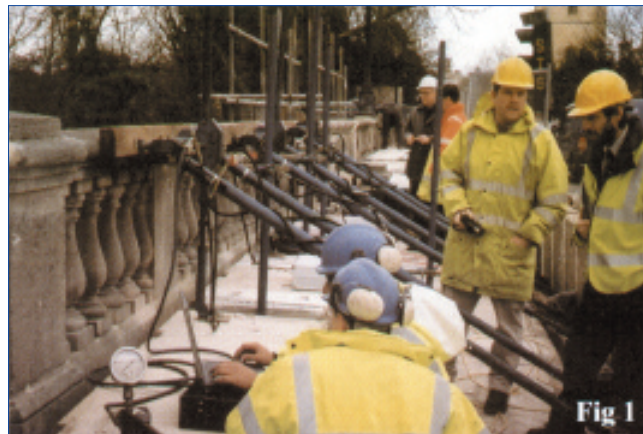
Fig 1

In February 2002 another section of parapet was tested on the South West side over the first span heading towards Oxford. The section had been reinforced with Cintec anchors over a 5.66m length. It was conducted in compliance with the requirements of 'The Home Office Guide to Safety at Sports Grounds' Fourth Edition and used specially designed barrier load testing rigs (see figure 1). Deflections were monitored with dial gauges having a resolution of 10 microns.

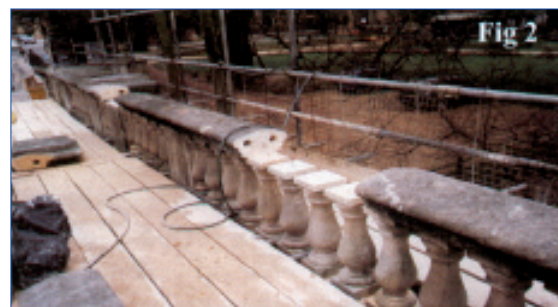
Fig 2

Figure 2 shows the holes drilled horizontally through the parapet. Figure 3 shows a horizontal cintec anchor prior to installation.

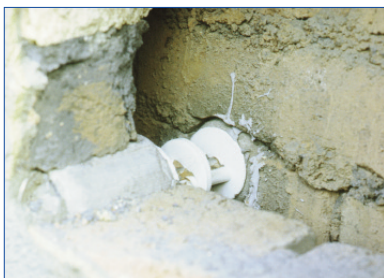
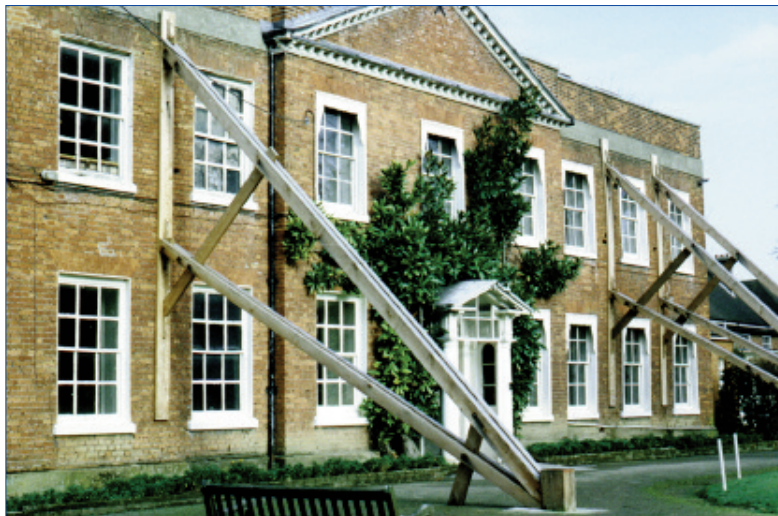
The front elevation of the building itself presented great problems. The facing wall comprised a thin 100 mm skin built without foundations. Of late Victorian age, it was out of plane, cracked and severely out of plumb. Originally built in a straight line, the cavity between the facing wall and the main wall varied from 10 - 75 mm. There are no ties or connection, except for odd pieces of timber.

Soldier arches were provided over the window openings and seen to be displaced or cracked. A survey of the facing wall revealed out of plumb dimensions of 100 to 150 mm. These variations occurred haphazardly over the whole area of the front elevation.

It was decided that the wall would have to be rebuilt. Concern at the instability of this wall was such that it was decided that, until the rebuilding could be carried out, heavy and well braced shores needed to be erected to avoid collapse. The main wall to which the facing wall was added, varied in thickness from 300 to 600 mm as piers, with infilling of solid brickwork, in general 300 mm thick.
