## STABILISATION OF DRY STONE RETAINING WALL AT ABERSYCHAN FOR TORFAEN COUNCIL

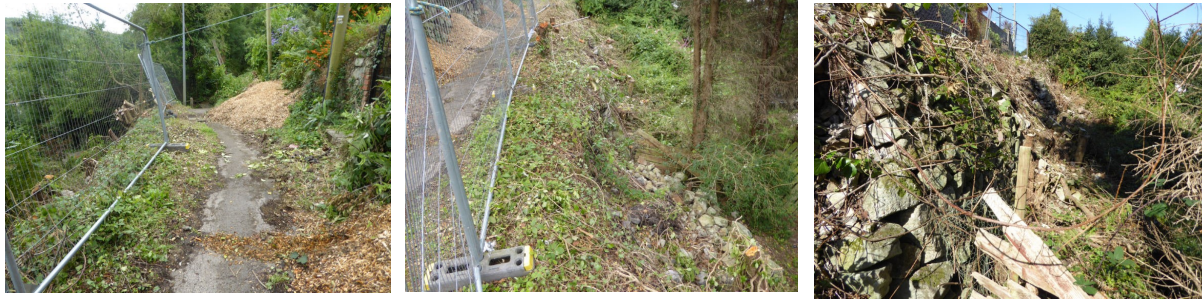
Torfaen County Borough Council were faced with a problem of a failing dry stone retaining wall at Tegfan which retained a small road adjacent to private gardens on a steep hillside.

As may be seen from the above photographs the wall had some substantial vegetation growing from it which has further exasperated the stability of the structure.

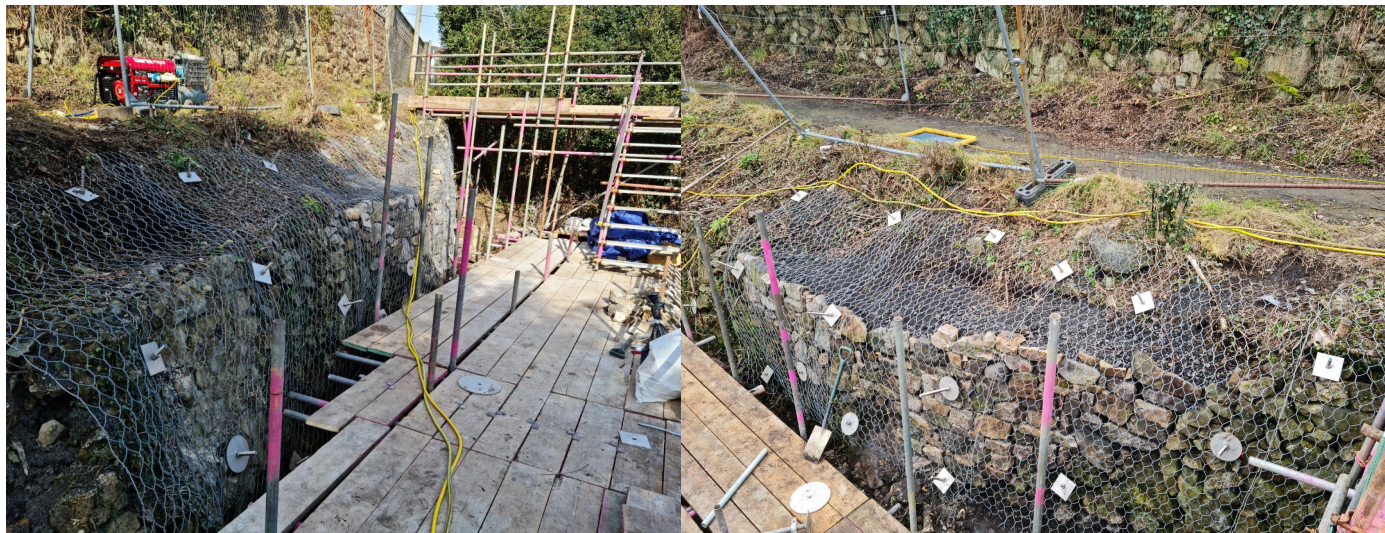
The cost was approved and Cintec instructed to proceed with the works subsequent to the client's team clearing the site of vegetation and loose masonry. They also provided the scaffolding.

16 number Cintec GB24 ground anchors in a 65mm diameter hole and 6.95 metres long were installed in accordance with the engineer's design as the main restraint to tie the loose masonry wall back into the hillside slope. Additional Cintec GB20 anchors by 2.40m long were installed to secure the geo-mesh to the substrate and to hold the loose masonry in place to prevent further movement and loss of integrity of the wall.

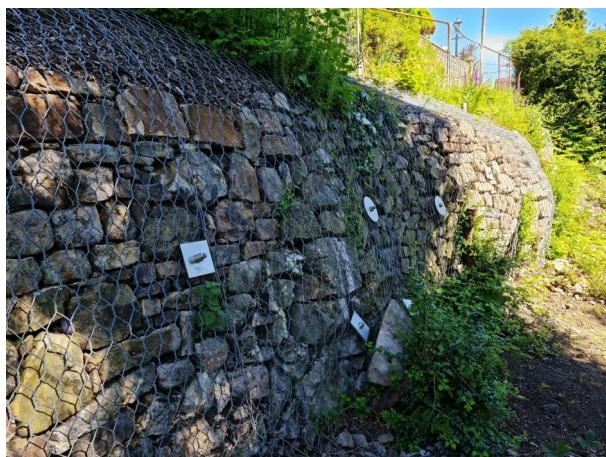
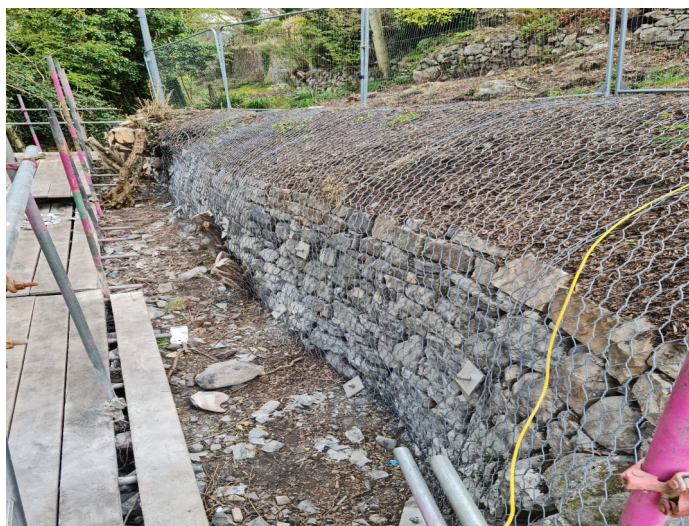
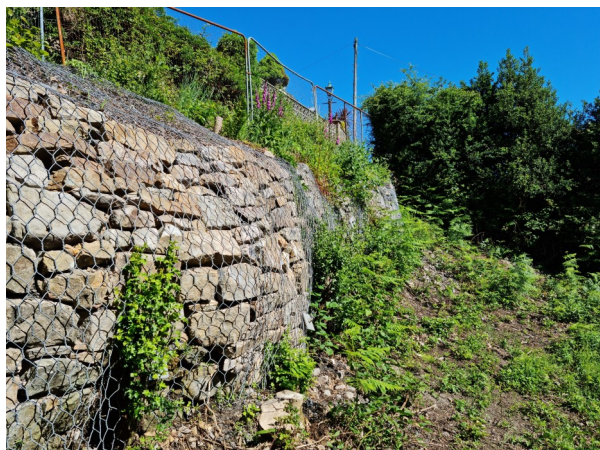
The completed wall stabilization was a great success which was completed at a fraction of the cost of traditional methods and completely overcame the problem of the limited access to the site. The fact that the wall separated the lane from a private garden wall also a major aspect that needed consideration on how the work should be carried out.
