# CASE HISTORY

## THE MADRASA & KANQAH OF SULTAN AL GHURI, CAIRO, EGYPT

## THE MADRASA & KANQAH OF SULTAN AL GHURI – THE DAMAGE

## THE MADRASA & KANQAH OF SULTAN AL GHURI, CAIRO, EGYPT – THE REPAIR

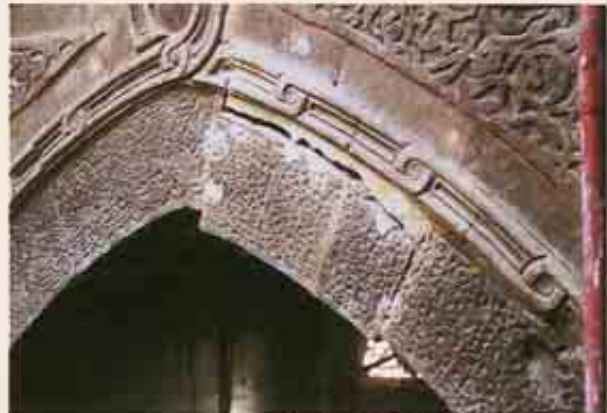
*Seismic damage to decorative arches*

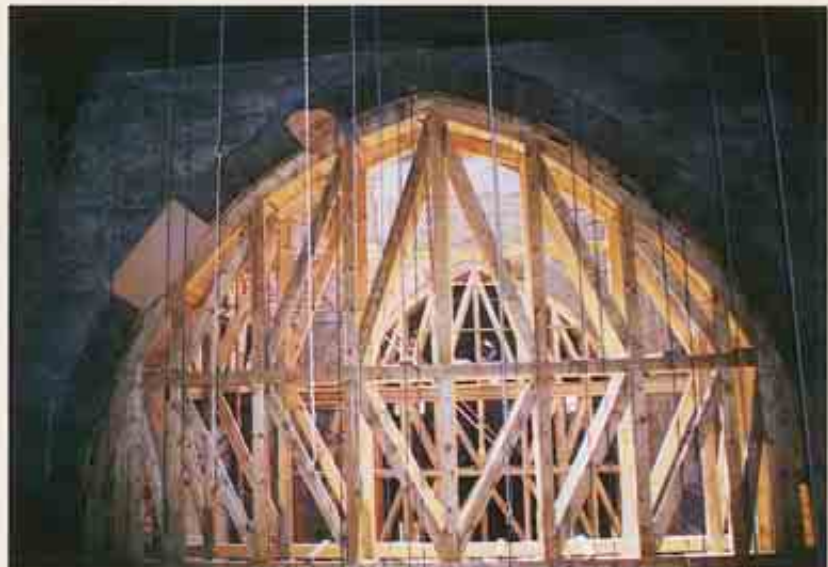
*Temporary support of the Dikka arches*

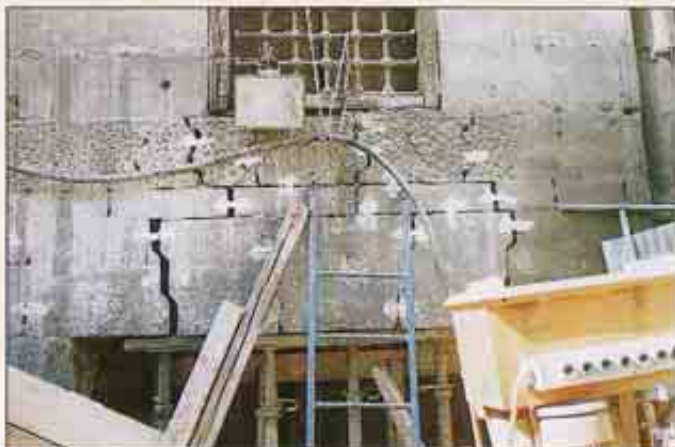
*Lintel stones*

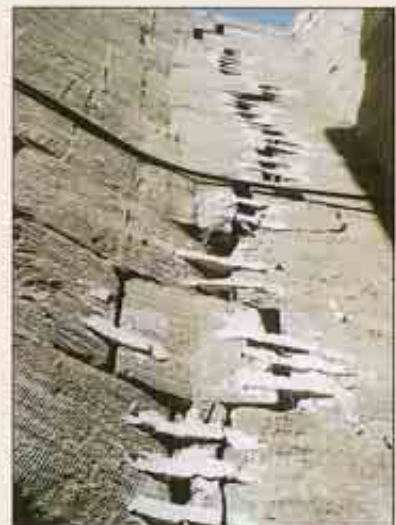
*Vertical shear crack*

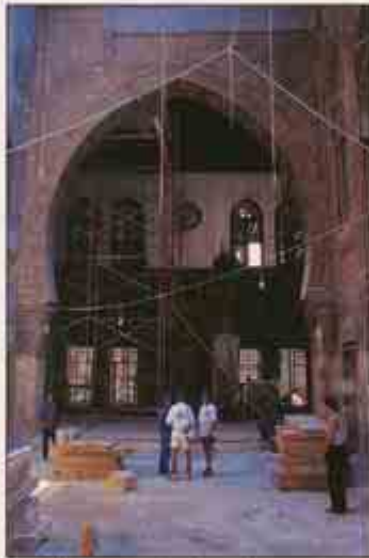
*Dikka arch in the main courtyard*

The Cintec stitching system was extensively used at al-Ghuri. These reinforcement anchors, up to 12 metres long, serve to stiffen each individual wall immensely. The walls of al-Ghuri are generally of two facing skins in-filled with a core of rubble. The large arched openings in the mosque are particular points of weakness in the structure. Longitudinal ties in each of the stone facings of the wall above the arch would serve to resist the thrusts naturally produced by the arch as well as serving to assist the walls to resist the next earthquake. In addition to longitudinal ties, transverse ties of length equal to the thickness of the wall were introduced to increase the strength of the wall.

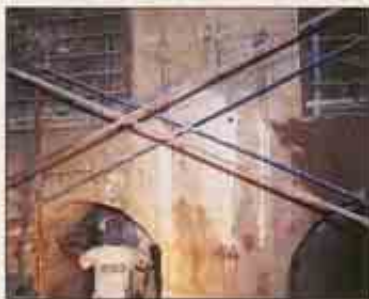
*Drilling the vaults*

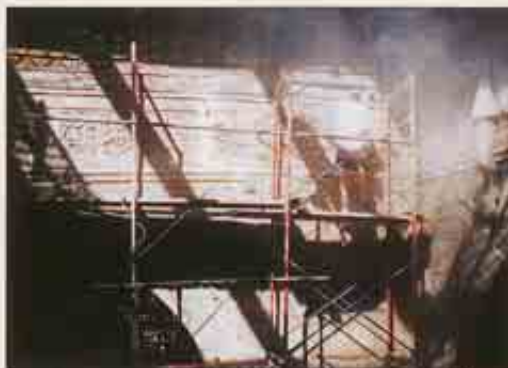
*Decorative panels being drilled ready for installation of consolidation anchors*

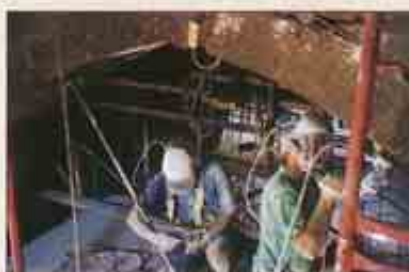
*Diamond drilling the arch stones*

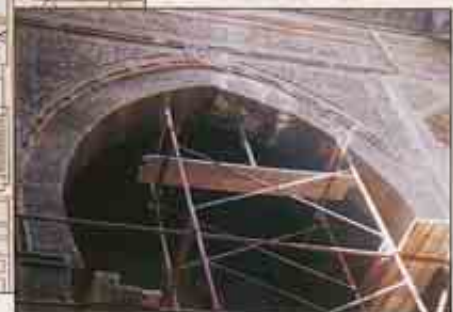
*One of the four arches of the court being scaffolded prior to drilling and anchoring*

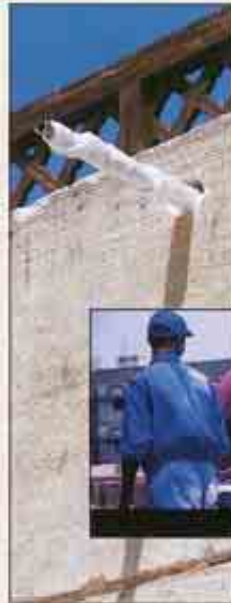
*typical consolidation anchor prior to grout injection*

The Cintec stitches would also be used to tie the roof structure to the perimeter walls and create a diaphragm action. Again this is an internationally recognised system of introducing greater stiffness and earthquake resistance into a structure. The beauty of the Cintec anchor is that it contains the grout to be used within a sleeve and control of grout flow and its impact upon the existing structure is therefore very good.

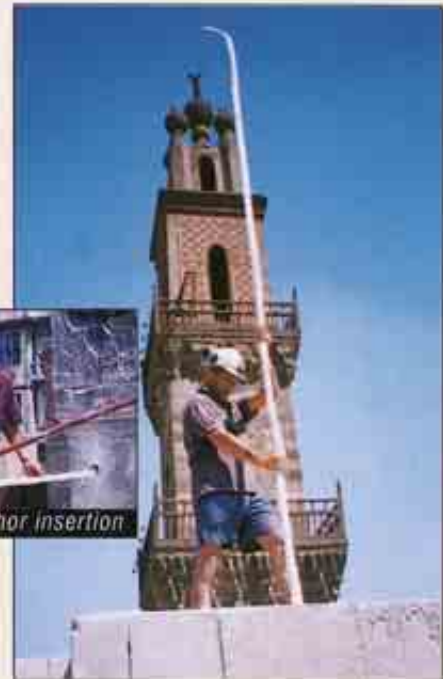
*5 metre long vertical anchors at roof level*

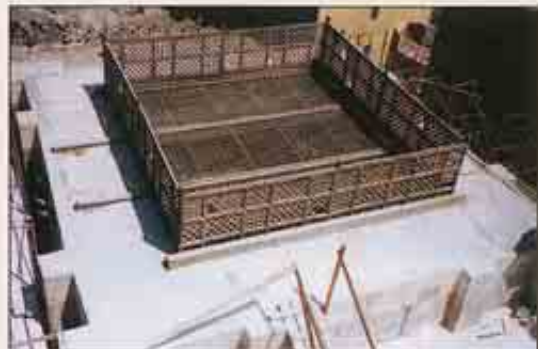
*Roof section above central courtyard*

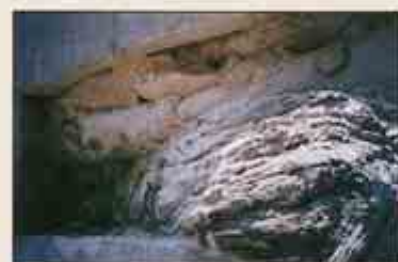
*installed roof anchor*
