# THE STRENGTHENING OF BROXBOURNE ARCHES FOR HERTFORDSHIRE COUNTY COUNCIL, UK

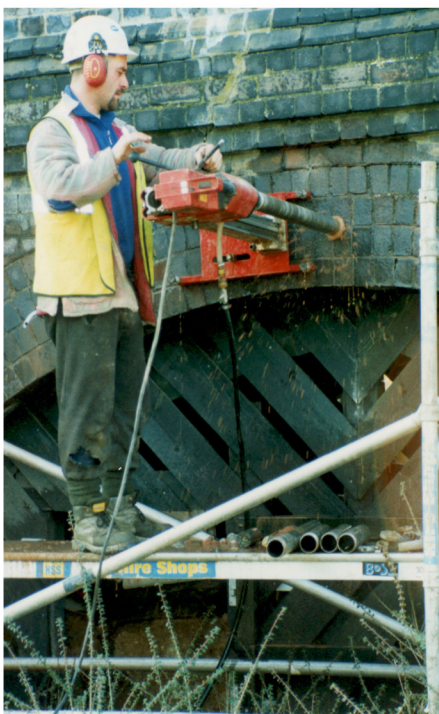
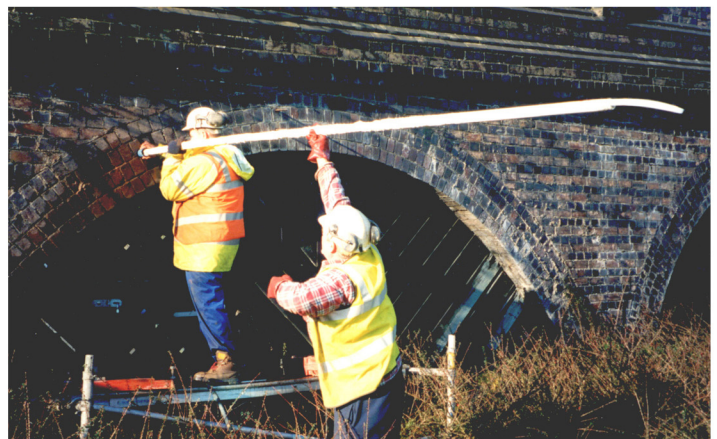
Lateral drilling and anchor installation to stabilise and consolidate cracking within arch rings.

The project involved the excavation of some of the ground in the immediate area of drilling to provide the angle for the insertion of the main anchors. A total of 75 x S25 Stainless Steel Type 2 Ribbed Reinforcement (Grade 460 to BS 6744) strengthening anchors 3.2 metres long were installed each in a 65 mm diamond drilled hole between 4.5 and 4.7 metres in depth. There were also 12 transverse anchors (S25 in a 65 mm hole) each 5.2 metres long installed in the "Lido Arches", and 420 Remedial Anchors (Circular).
