# West Block- The Canadian Parliament Buildings - Ottawa, Canada

**Cintec West Block Restoration** The West Block was constructed between 1860 and 1865. In 1897 the building was damaged by fire. The West Block is one of the three buildings on Parliament Hill in Ottawa, Ontario that forms part of the Parliamentary precinct. The West Block after renovation now houses offices for Parliamentarians, a branch of the Library of Parliament, committee rooms, and some preserved pre-Confederation spaces, which are used for some state occasions. All Canadian laws now originate here.

# CINTEC

### THE REINFORCEMENT & STABILISATION OF THE BUTRESS & PINNACLES WITH 2 stage post tensioned Cintec Reinforcement Anchors up to 35.5 Ft [10.8m] long

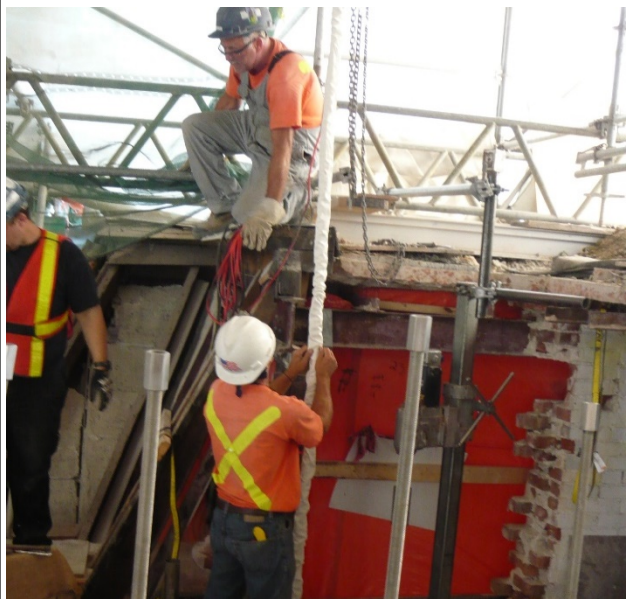
Installation photo and structural drawing of type G anchor used to strengthen / seismic upgrade of towers. The letter G was used to define anchor for Engineer / Project purposes BUT does not define a specific Cintec anchor configuration

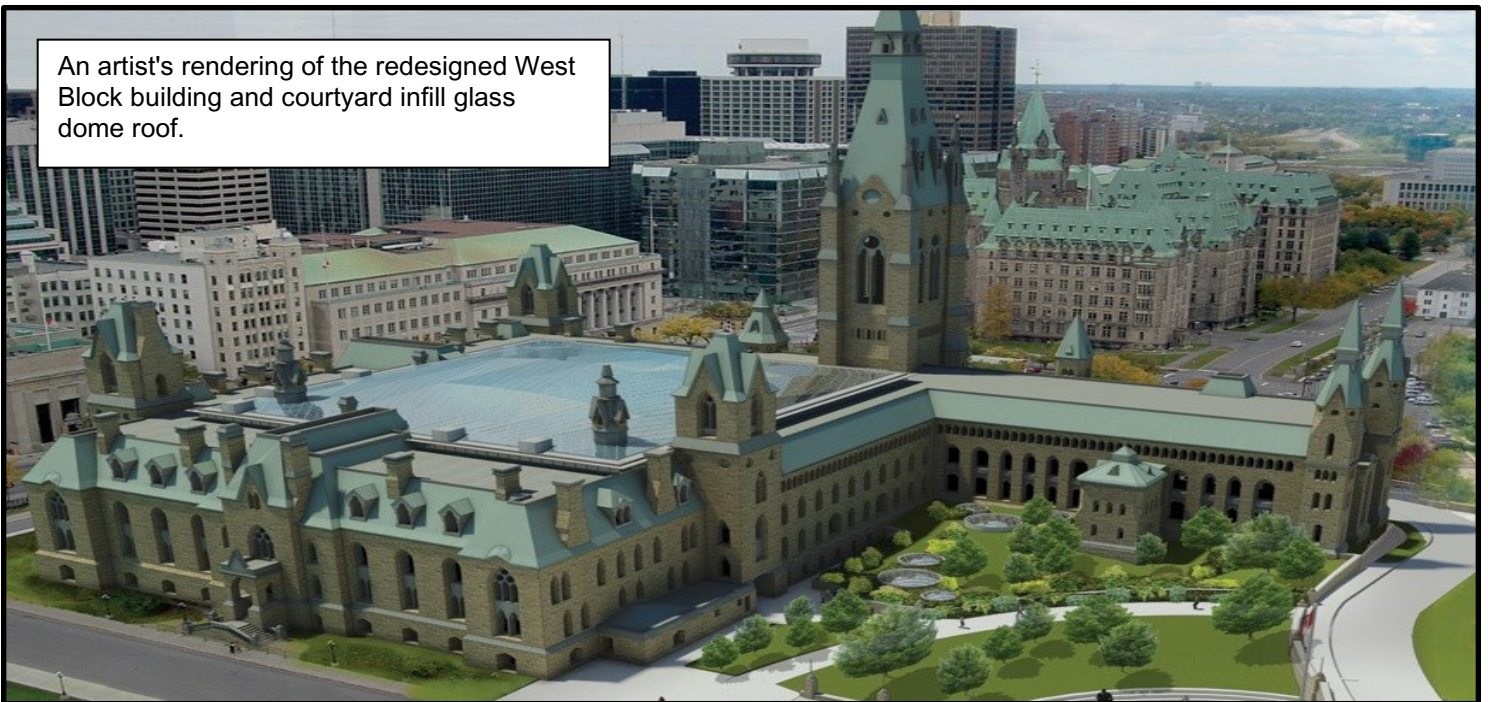
An artist's rendering of the redesigned West Block building and courtyard infill glass dome roof.

The central courtyard of the West Block was transformed into a temporary chamber for the House of Commons (see anchors used above). The new chamber is surrounded by exterior stone walls and covered by a glass dome roof which lets in natural sunlight (see below). Multiple underground levels as well as planned tunnel connections to other Parliament Hill buildings were constructed out of dug-out bedrock under the West Block during the extensive renovations
