# **Reinforcement of Historical Masonry with Long Internal Reinforcement Anchors**

## **Qualitative Analysis using Discrete Element Computer Modelling for Seismic Loading and Oblique Forces**

## **Application: The Restoration of Aizenay Church**

Illustrated by the project Aizenay Church:  
Putting in place an innovative solution for restoring buttresses in danger of collapse

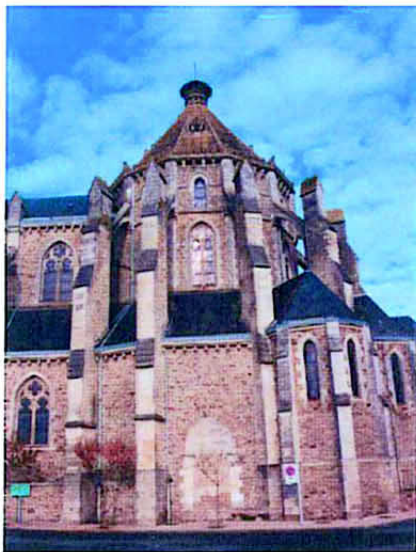
View of choir section

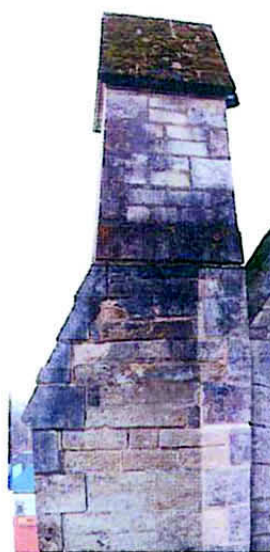
Ice damage and 'step' cracking

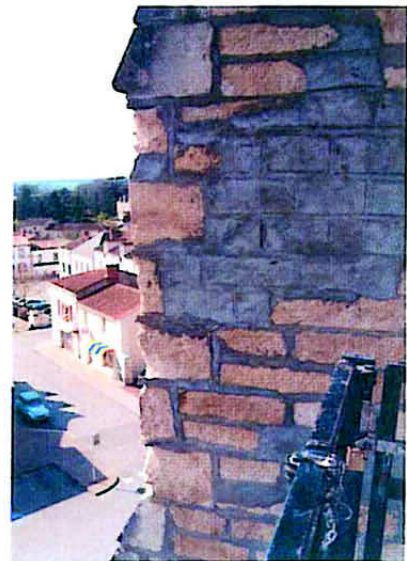
Degradation of limestone and old cement repairs

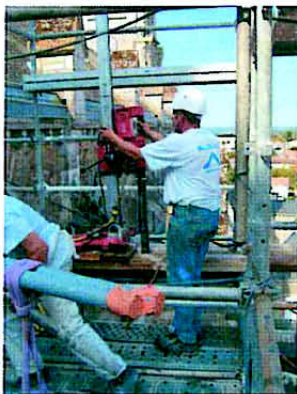
*The drilling*

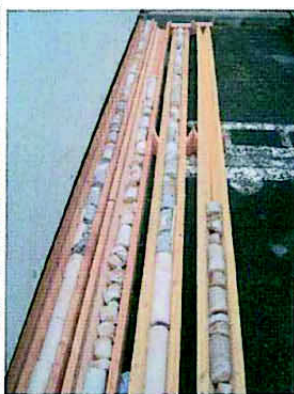
*The cores*

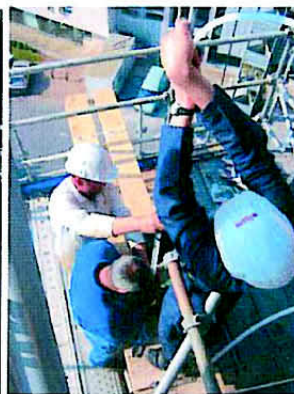
*The installation of a vertical anchor*

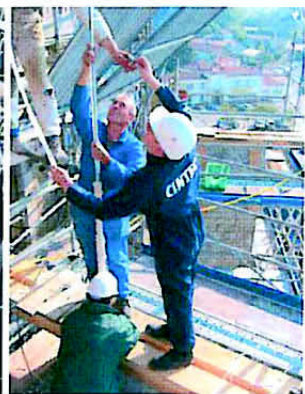
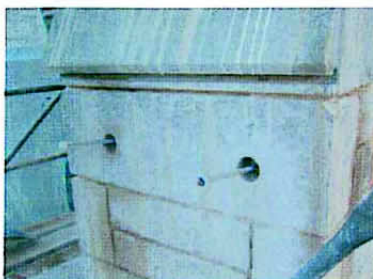
*Horizontal anchors ready for injection*

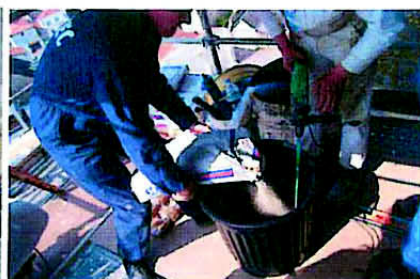
*Preparation of grout*

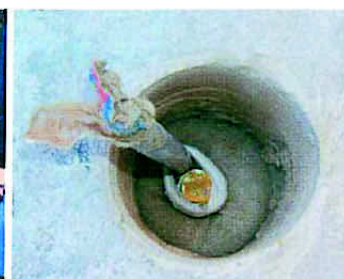
*Injected vertical anchor*
