## The strengthening of heritage marine structures in Jersey with needling technology

The three structures are the North Pier and South Pier of St. Aubin's Harbour and the St. Aubin's Fort Breakwater. Both structures are exposed to waves from the south west and act as breakwaters.

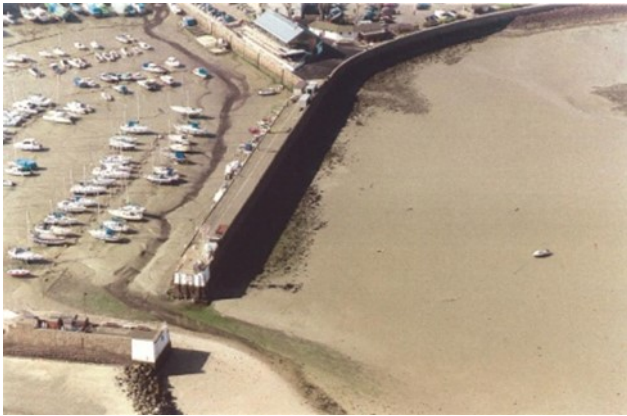
Above North Pier and below St Aubin's Fort.

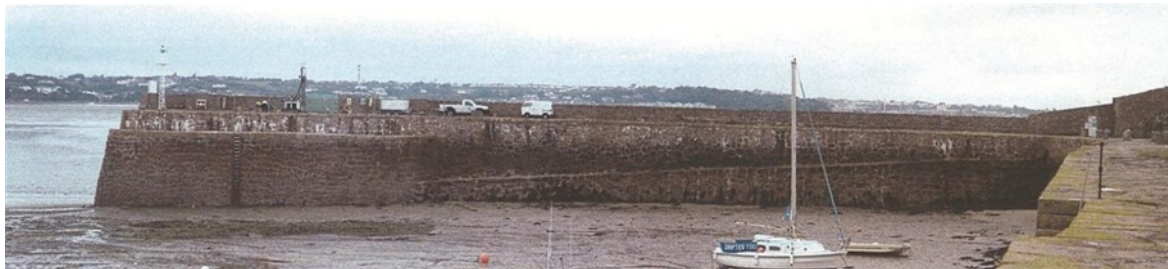
Large cracks had developed and could be seen in the asphalt surfacing indicating a threat of impending wedge failure of a section of the inner wall.

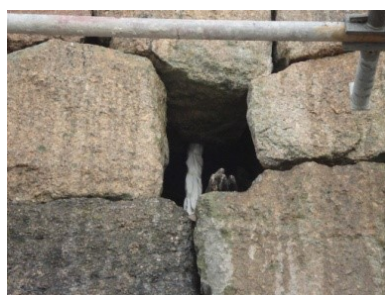
Pre-injection with masking tape

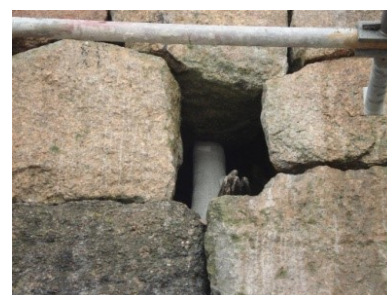
Anchor grouted & expanded

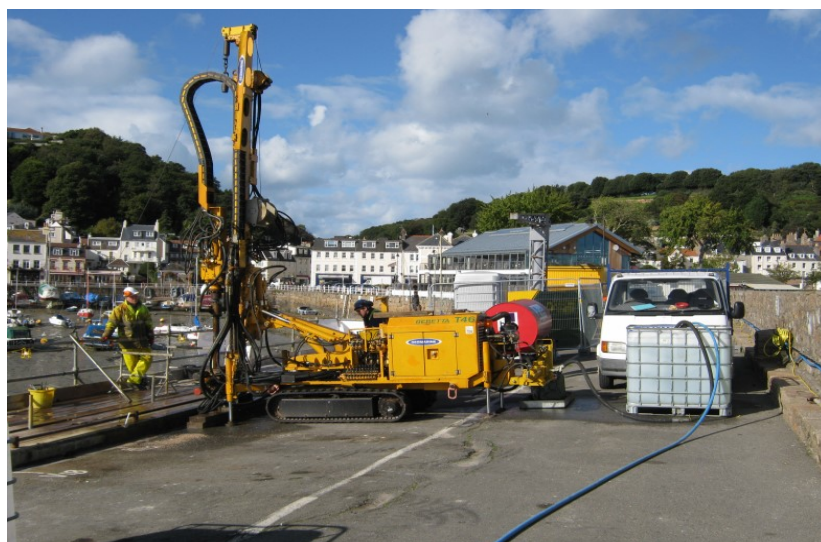
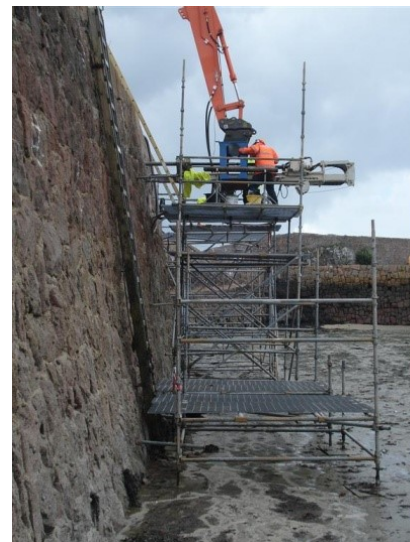
At the North Pier the vertical drilling works for the anchors took place through the inner wall concrete up-stand used for vessel mooring. Plugs in the masonry were reinserted to enable invisible fix once the anchor had been installed.
