## Leaderfoot Viaduct - Scottish Borders

*"Key hole Surgery for Bridges"*

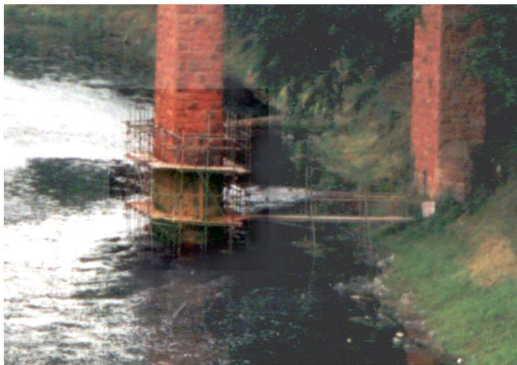
View of drilling platform

Under the supervision of the local river authority, holes were drilled at a downward angle through the boots and into the piers. These instantly filled with river water, however due to the unique nature of the Cintec anchor - filling a mesh fabric sleeve from the rear to the front, all water was fully displaced upon grout injection. The visible cracks were sealed manually by inserting lengths of sock into the fissures and expanding them. The subsequent watertight seal allowed conventional grouting to be injected into any remaining internal voids without danger of release into the water system.
