# Mousewater Bridge

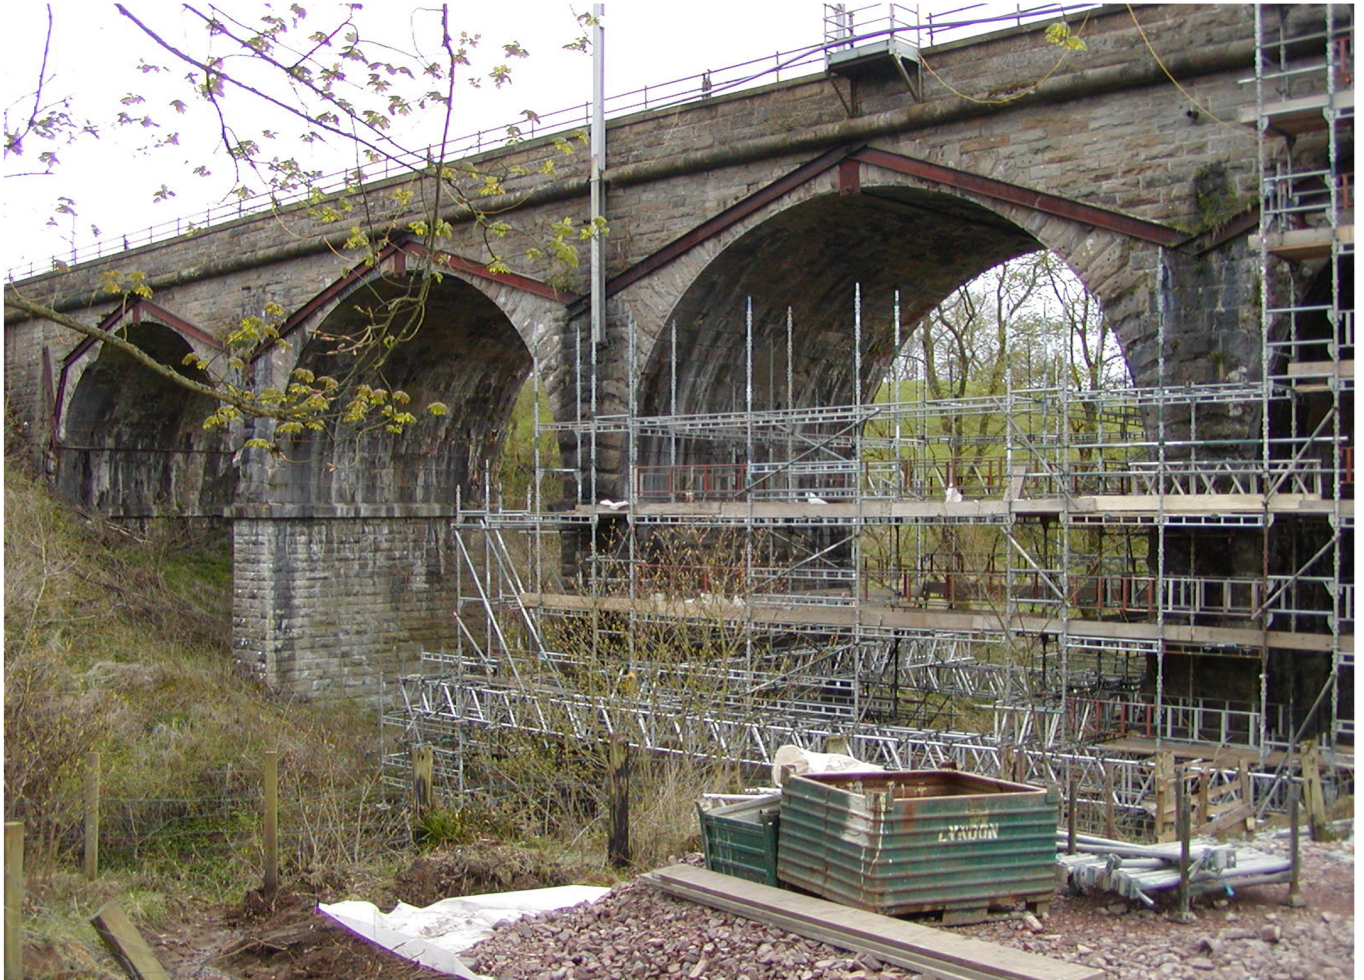
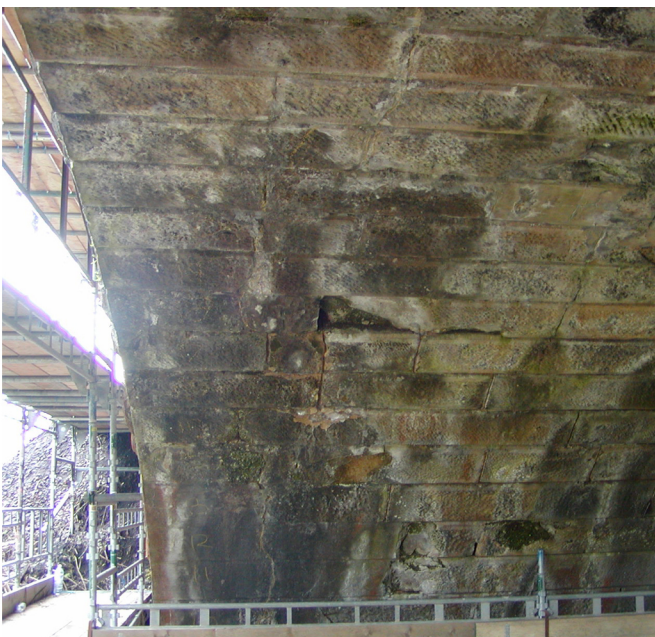
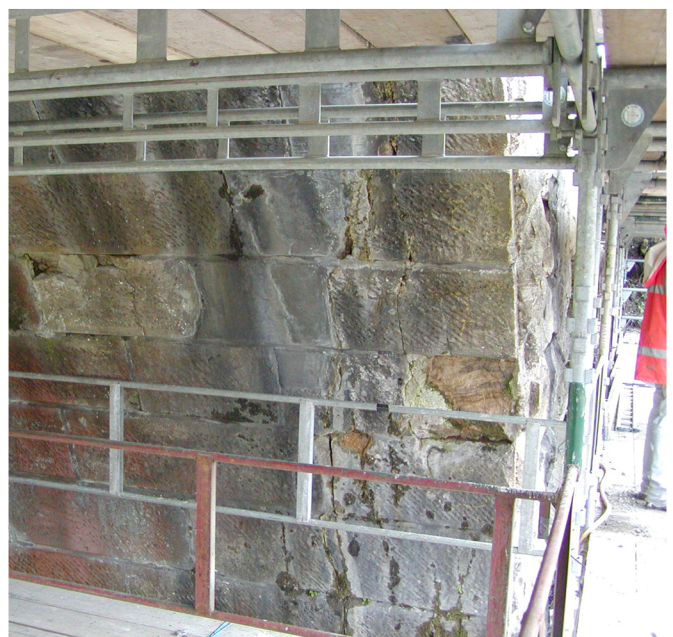
The slight curve in Mousewater Viaduct caused trains exert centrifugal forces within the structure. In consequence, radial cracking developed within the spandrel walls above the piers. 16mm stainless steel rebar anchors were installed in 50mm diameter holes to repair cracking and 32mm grip bars and pipe anchors were installed into stepped holes and secured with 35mm end plates in order to 'clamp' the spandrel walls and contain bulging and internal settlement.

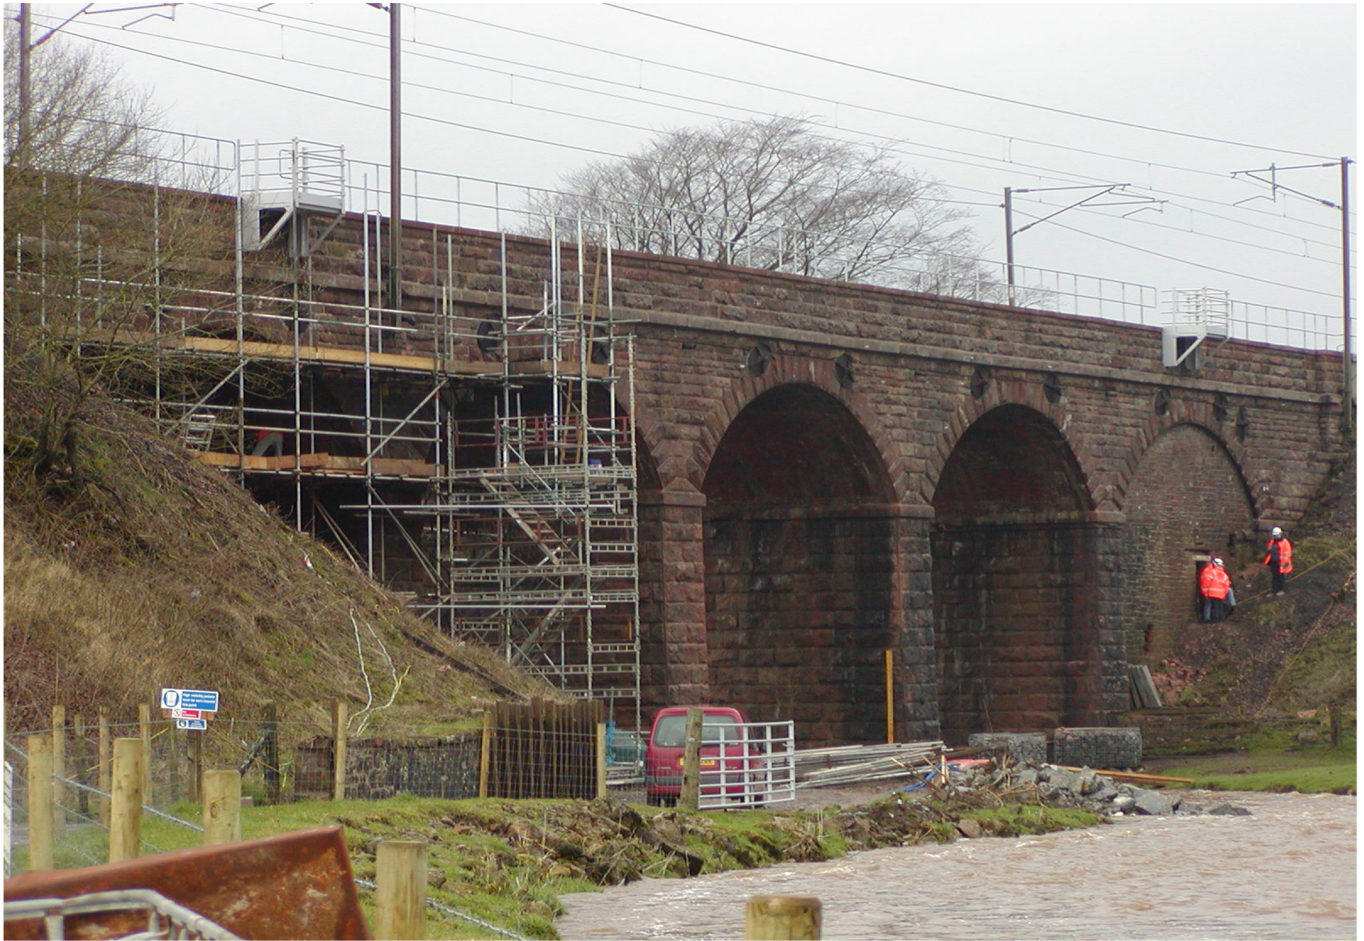
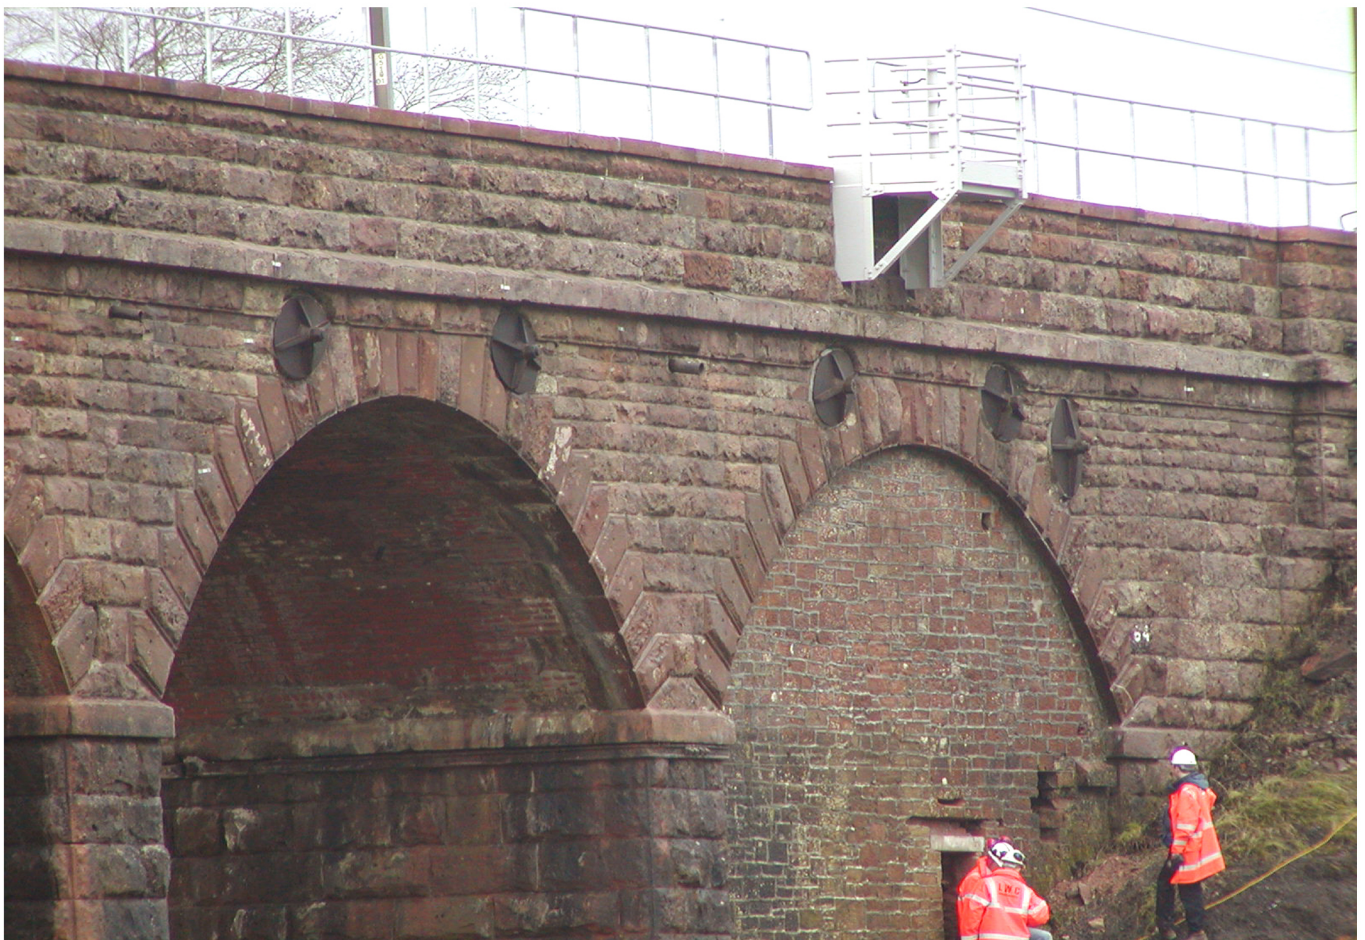
# Meinwater Bridge

Cintec Pipe anchors hidden within the stonework, counter forces imposed upon the spandrel walls.
