## ***Pont Telpyn Bridge***

# Pont Telpyn Bridge

Pont Telpyn bridge links the A525 at Rhewl with the B5429 and crosses the river Clywd. In 2008 during strengthening works the bridge suffered severe flood damage and was very near complete collapse, the only saving grace was that Cintec Archtec anchors were in the process of being installed, the installed anchors prevented the complete collapse of the bridge.

PROJECT  
PONT TELPYN 1 BRIDGE  
ARCH STABILISATION

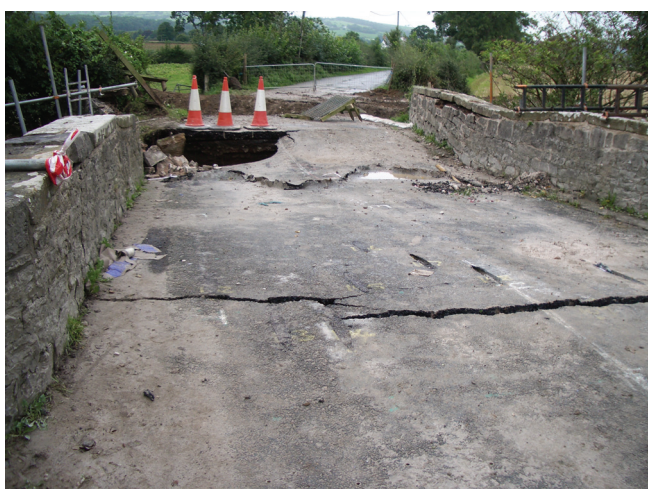
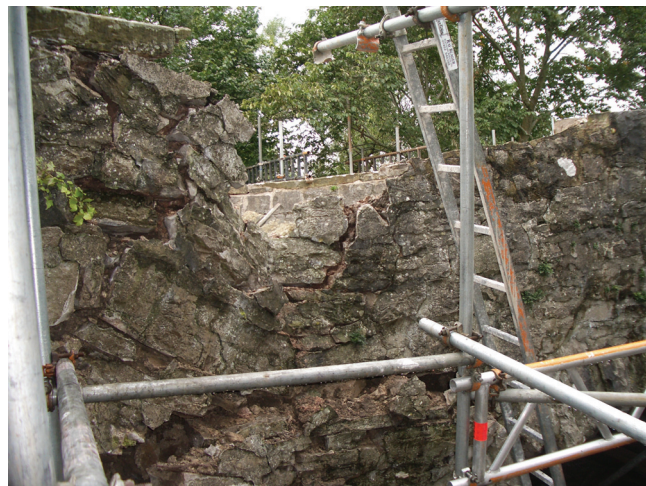
The movement of the road surface suggested that the arch barrel had rotated up to 4.5 degrees about the east springing. There was distortion of the arch barrel due to differential movement, resulting in a shear crack at the west upstream corner. The fact that this corner is lower than the adjacent arch barrel suggested that the abutment dropped vertically at this corner, followed by the adjacent arch barrel. Apart from this south west corner, the arch barrel was in reasonable condition.

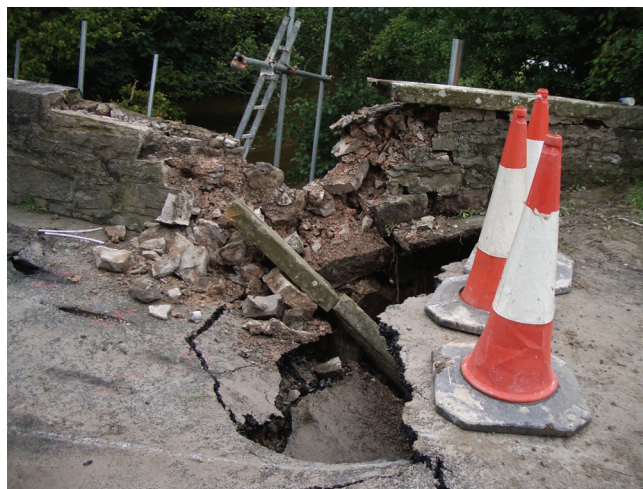
The damage to the upstream spandrel and parapet was mainly limited to the large area of damage above the west abutment and a significant crack above the east abutment. Damage to the downstream spandrel and parapet was more widespread, with cracking through mortar joints almost throughout the length of the wall.

The road surface showed three main failures, indicating tension failure above the east abutment, compression failure above the west springing and shear failure to the west of the bridge.
