## RETAINING WALL STABILISATION, ST GEORGE'S ROAD, SHANKLIN, ISLE OF WIGHT

A failing retaining wall adjacent the public footpath and highway posed a danger to pedestrians, traffic and occupants of the dwelling behind the wall.

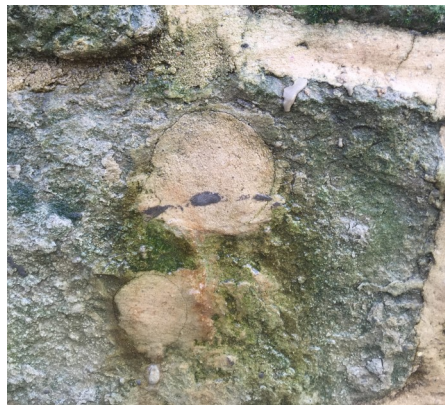
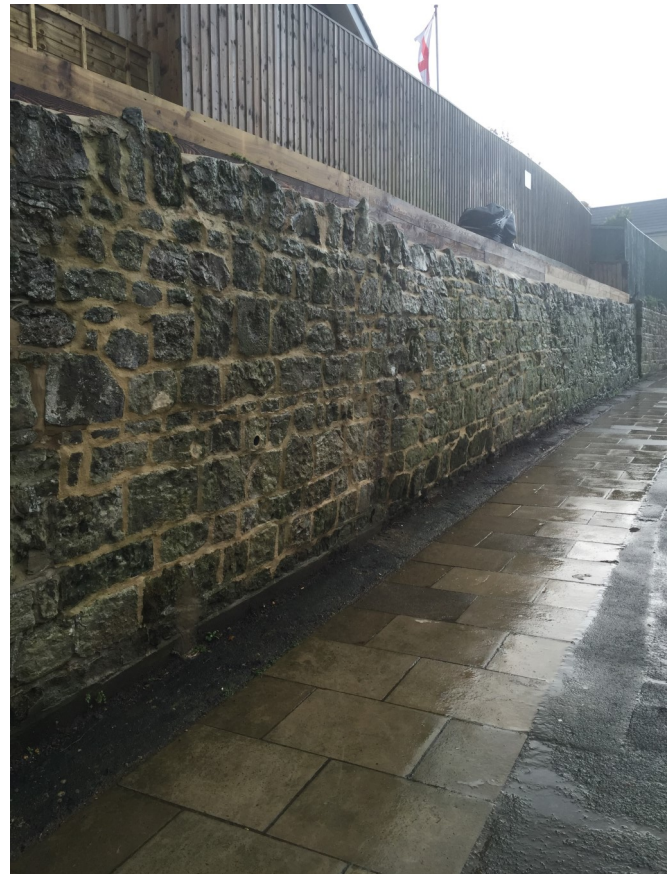
The seven vertical and inclined ground anchors were Cintec 20mm diameter stainless steel bars in a 65mm diameter diamond core drilled hole each being approximately 4500mm long. Additionally Cintec consolidation anchors were installed at 500mm grid horizontally and vertically. Ends of anchors were recessed and pointed over without the need for unsightly patress plates.
