# Teviot Viaduct - Roxburgh

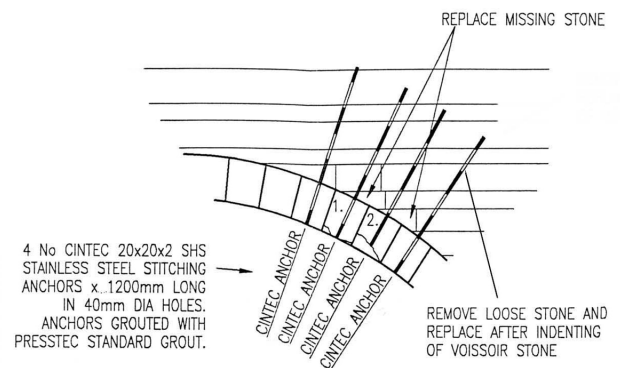
PART ELEVATION OF VOISSOIRS/SPANDREL FACE.

The first phase of restoration involved the replacement of broken and missing voussoir stones from the arch barrels. In order to reduce the risk of a progressive collapse, neighbouring stones were held in position by square hollow section stitching anchors 1.5m in length, this consolidated the arch while the replacement stones were installed.

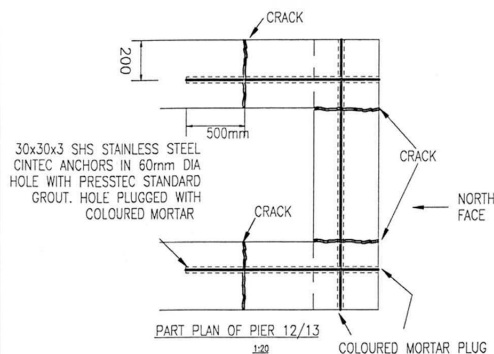
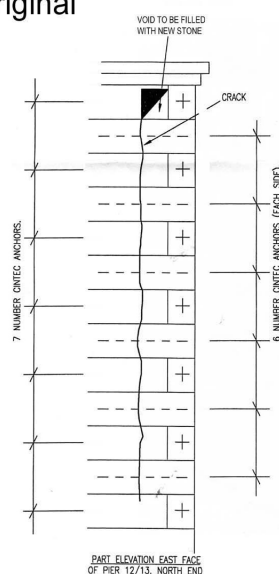
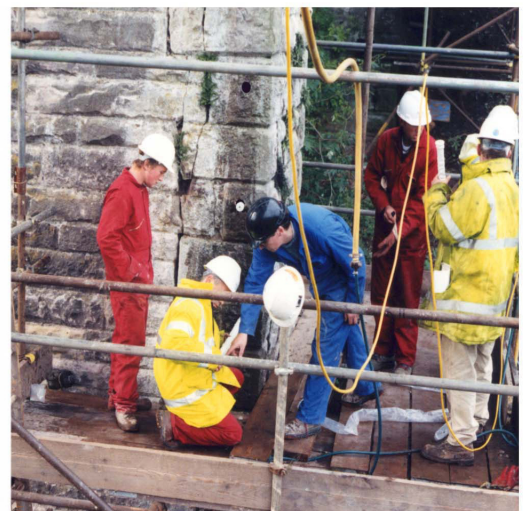
The second phase of work involved interlocking the outer masonry walls of each pier. The original design drawings and the photograph (below and right) reveal the extent of the cracking and the subsequent Cintec solution. In total 112 anchors were installed.
