# CASE HISTORY

## MARRIOTT HOTEL - LIVERPOOL AIRPORT, ENGLAND, U.K.

## GEOFFREY HARRIS HOUSE, CROYDON, ENGLAND, U.K.

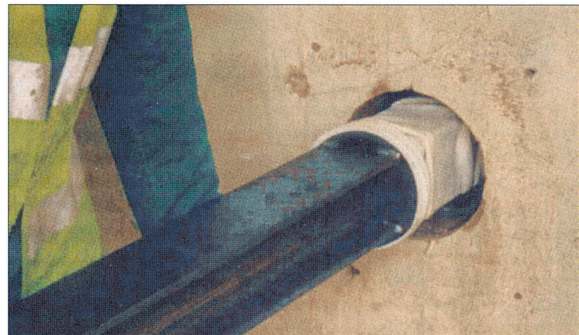
Insertion of Cintec section of 'I' beam into brickwork

A 200 mm (8 inch) diameter, 450mm (18 inch) deep hole was hand cored by diamond drilling into the brickwork.

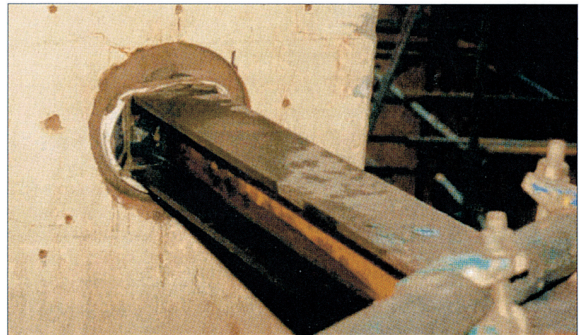
'I' beam following grout injection

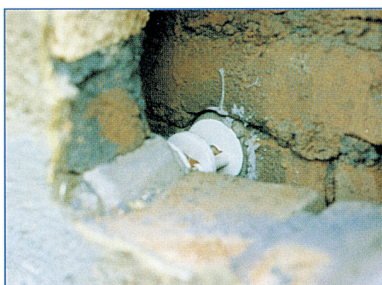
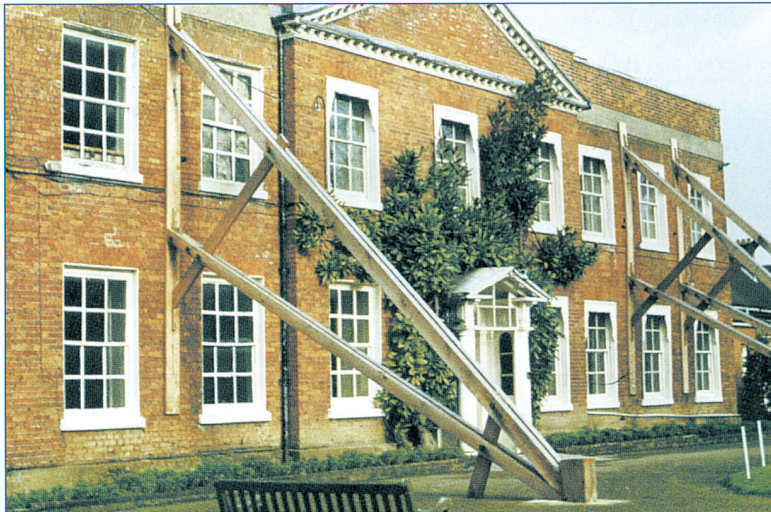
The front elevation of the building itself presented great problems. The facing wall comprised a thin 100 mm skin built without foundations. Of late Victorian age, it was out of plane, cracked and severely out of plumb. Originally built in a straight line, the cavity between the facing wall and the main wall varied from 10 - 75 mm. There are no ties or connection, except for odd pieces of timber.

Soldier arches were provided over the window openings and seen to be displaced or cracked. A survey of the facing wall revealed out of plumb dimensions of 100 to 150 mm. These variations occurred haphazardly over the whole area of the front elevation.

It was decided that the wall would have to be rebuilt. Concern at the instability of this wall was such that it was decided that, until the rebuilding could be carried out, heavy and well braced shores needed to be erected to avoid collapse. The main wall to which the facing wall was added, varied in thickness from 300 to 600 mm as piers, with infilling of solid brickwork, in general 300 mm thick.

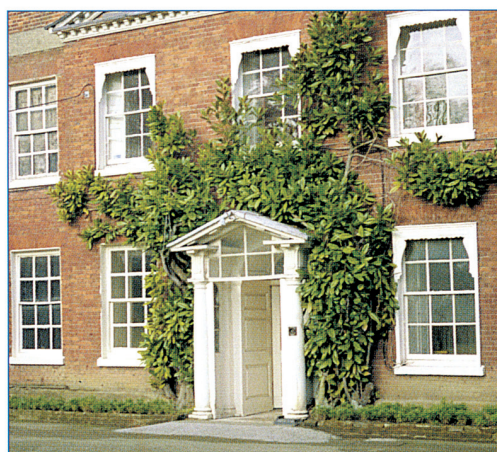
It involved using stitching anchors to fix the facing skin to the main wall. The wall was then tied back to a solid internal wall.

The fixings used to anchor back the external wall were 30 mm x 30 mm WSA fixings. The repair solution involved inserting anchors into the external and internal walls at approximately 450 mm centres.
