## The Carriageworks, Stokes Croft, Bristol.

They were built in 1862 by Edward William Godwin from Pennant stone with Bath stone dressings. It has round arched arcades above double width segmental arches. The ground-floor arches were originally open for access by John Perry and Sons' carriages. The façade required attaching to the new structural steelwork of the redeveloped site and is a listed structure as being a fine example of Byzantine Revival architecture.

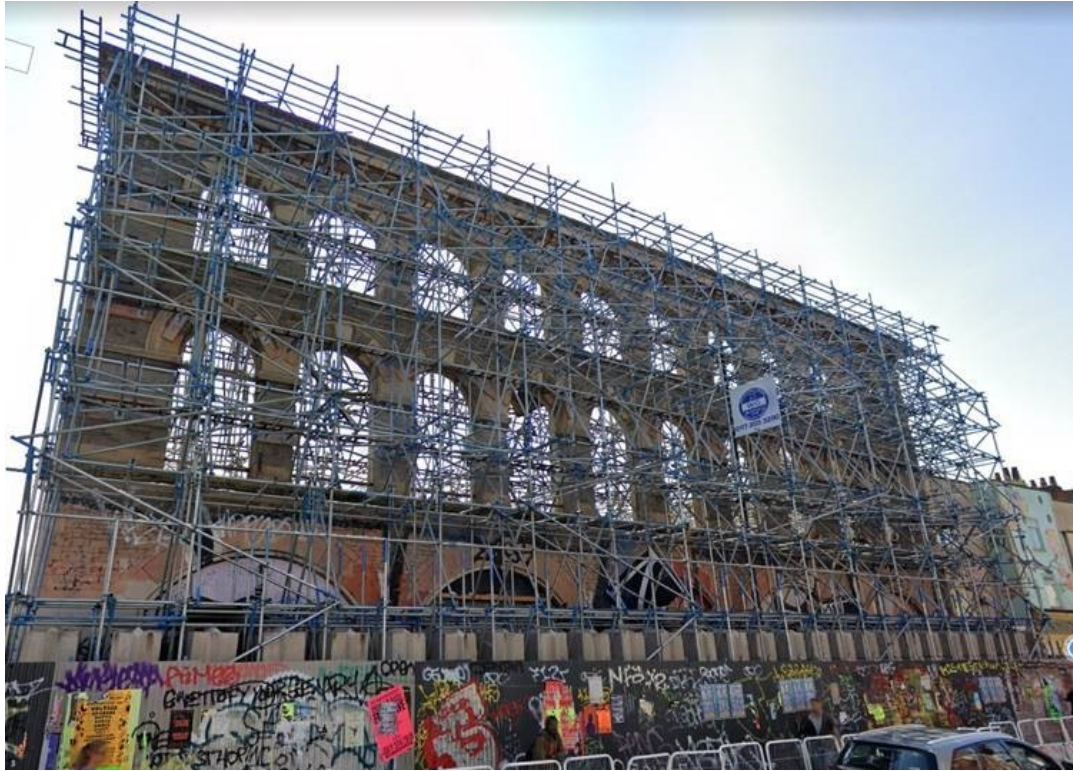
The building had remained in a very poor neglected and derelict condition for over 35 years and during the past few years a design scaffolding had to be erected to provide support to the listed facade as some buildings behind were becoming dangerous.

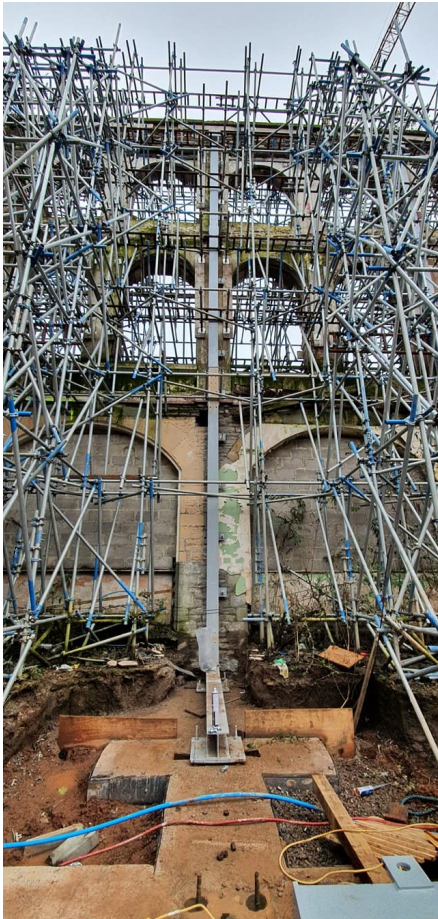
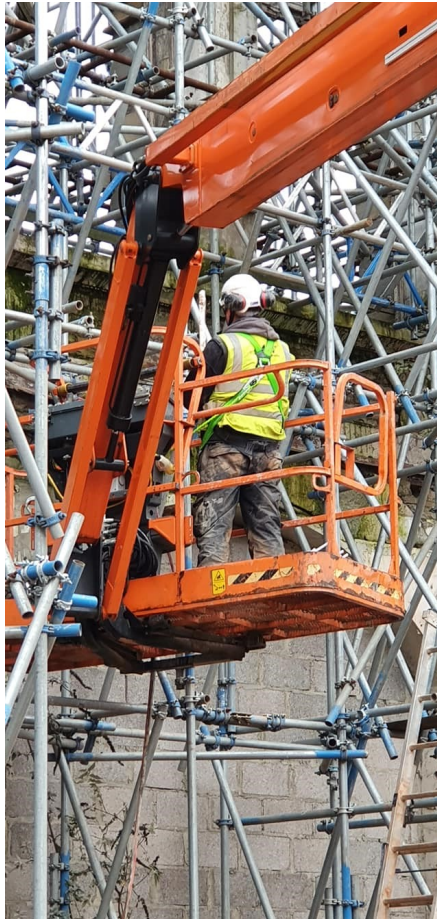
Falcon's operative's have regular H&S and powered access training and possess IPAF Licences, allowing them to operate the mobile elevating work platforms, as shown in some of the photos below and demonstrates the constraints that Falcon's team had to work under.

Working closely with the PG Site Team and Craddys structural engineers, Falcon installed the stainless steel Cintec Gripbar anchors into the masonry facade. The M16 x1000mm long Cintec Gripbar anchors were diamond cored and embedded into the inner face of the masonry facade for a 600mm depth.

Each steel column was fixed back to the facade with 12 number Cintec anchors equally spaced and a similar fixing strategy was also proposed for the steel floor beams.

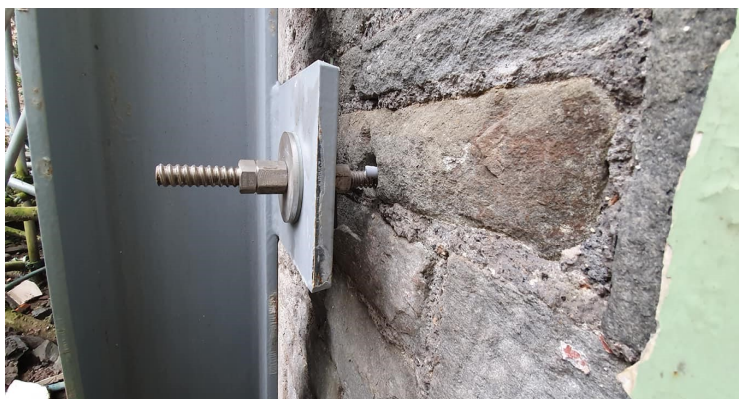
Above: every anchor was precisely positioned and set out to align exactly with the pre-drilled holes in the structural steelwork. All anchors were fitted with both a nylon and stainless steel washer, a load nut and locking nut.
