# CASE HISTORY

## FULLER'S BREWERY, LONDON U.K.

## TRIAL BY FIRE

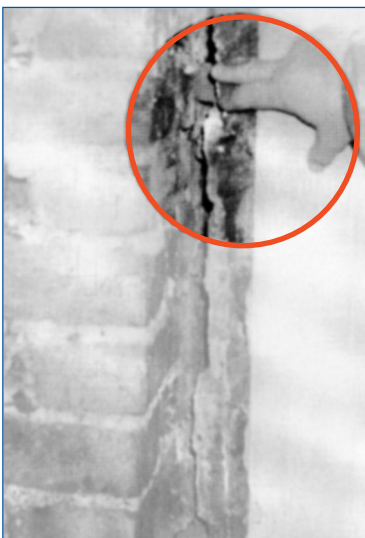
Remedial anchors installed prior to the fire. The anchors are still functioning. The grout cover protected the main steel body of the anchor.

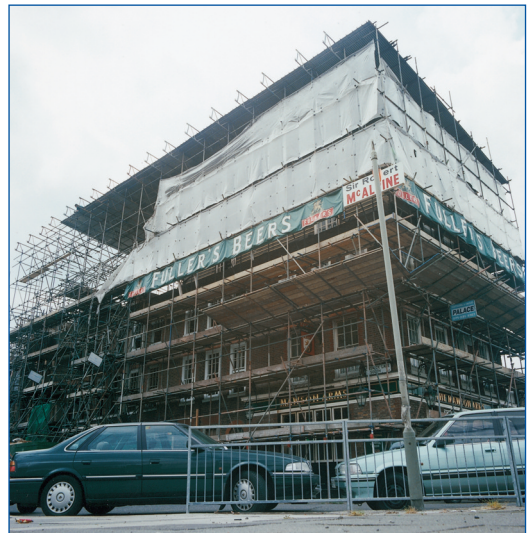
Even though the brickwork had been subjected to extreme temperatures, the anchors survived well; pull out tests revealed that they still performed to their original design specification.
