## Hemsley Building 230 Park Avenue, NY, NY U.S.A

### The Property

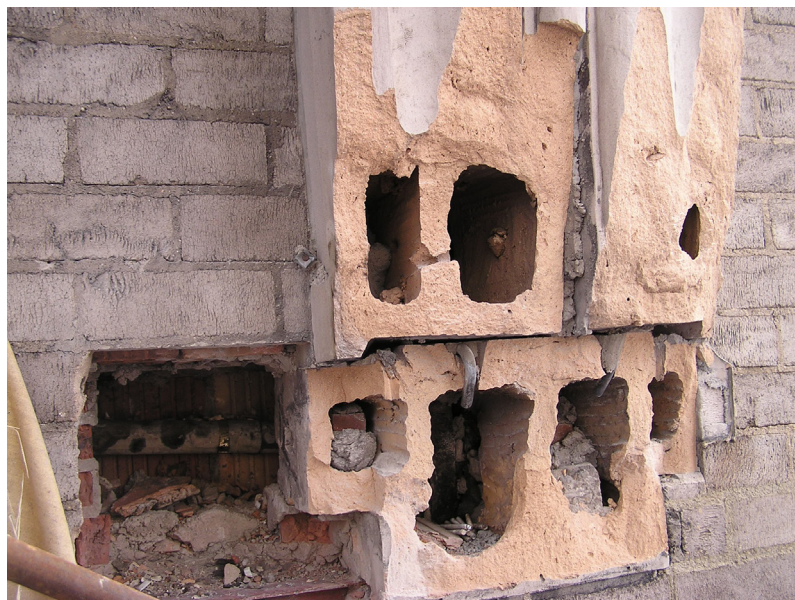
By 2009, the building had begun to show its age. At the top of the building some of the twenty-six east and south facing Terra-Cotta columns [ with the base starting at the 26th floor and extending past the 34th floor] had begun to show cracking and in some areas had begun to shed large pieces of stone. The building owners/management had inquired as to replacement cost of these Terra-cotta Brackets and had been quoted prices exceeding 16 Million dollars. By employing the Cintec method of repair, the owner was able to save more than 15 million Dollars effecting by repairs for just over 1million dollars.
