## HOLDENBY HOUSE, NORTHAMPTONSHIRE

In 2016 structural engineers PRP from Northampton engaged Cintec to assist with the stabilisation of the rear part of the old building which was showing signs of movement to one wing.

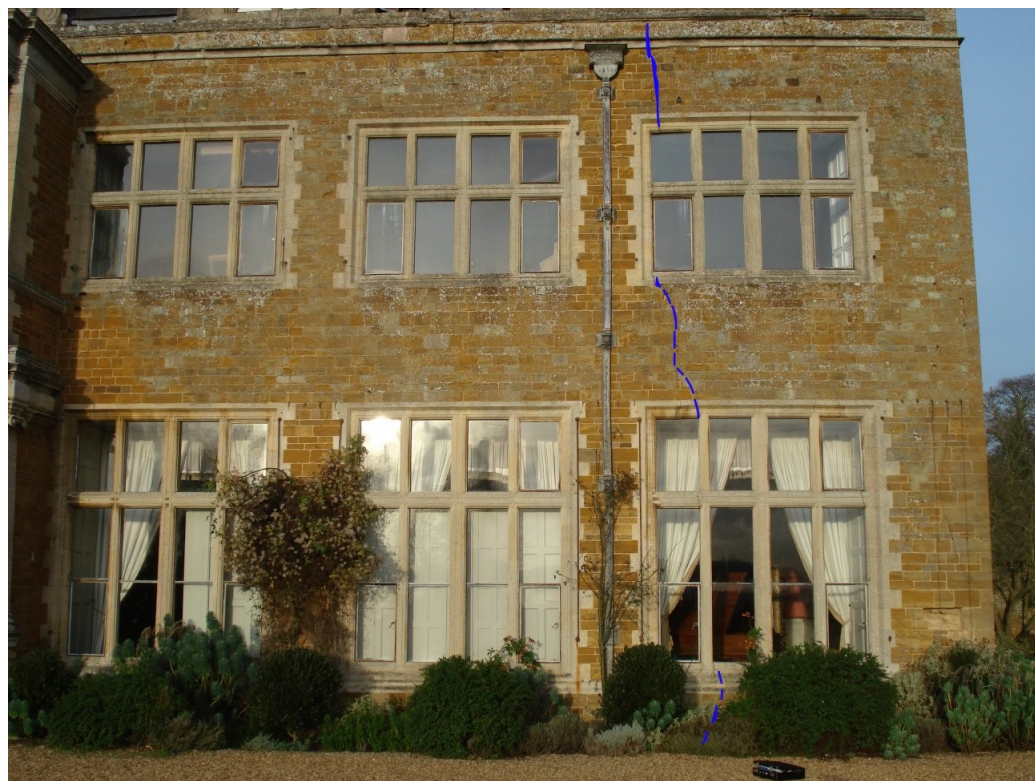
The movement was evidenced by cracks running in a vertical plane from eaves to the foundations as indicated on the photo to the left.

Crack monitoring had been in place for three years and seasonal movement recorded which was determined to be thermal.

The solution was easily overcome by installing a set of four horizontal 20mm diameter stainless steel anchors dry diamond core drilled in 65mm holes and 6.00 metres long below, between and above the existing fenestration adjoining the vertical crack.

The outer skin of natural stone was saw cut vertically to allow the insertion of a compressible expansion / movement joint to cater for any future movement. This was eventually concealed by the existing rainwater pipe.
