## PUGIN HALL, RAMPISHAM , DORSET

Pugin Hall, former rectory, now a private house, built 1846-7 by A.W.N. Pugin for the Rector of Rampisham. Pugin was one of the most important and distinguished architects of the Victorian period, renowned for his originality and attributed with reviving the popularity of Gothic architecture in the mid C19. It is a Grade 1 listed building.

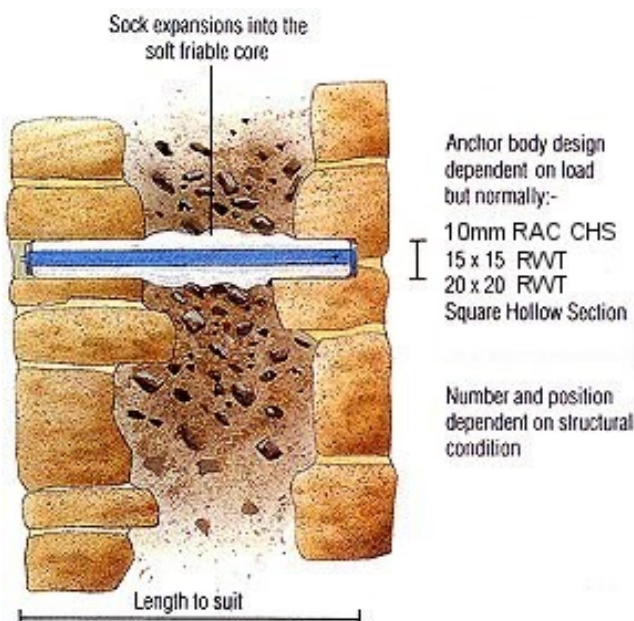
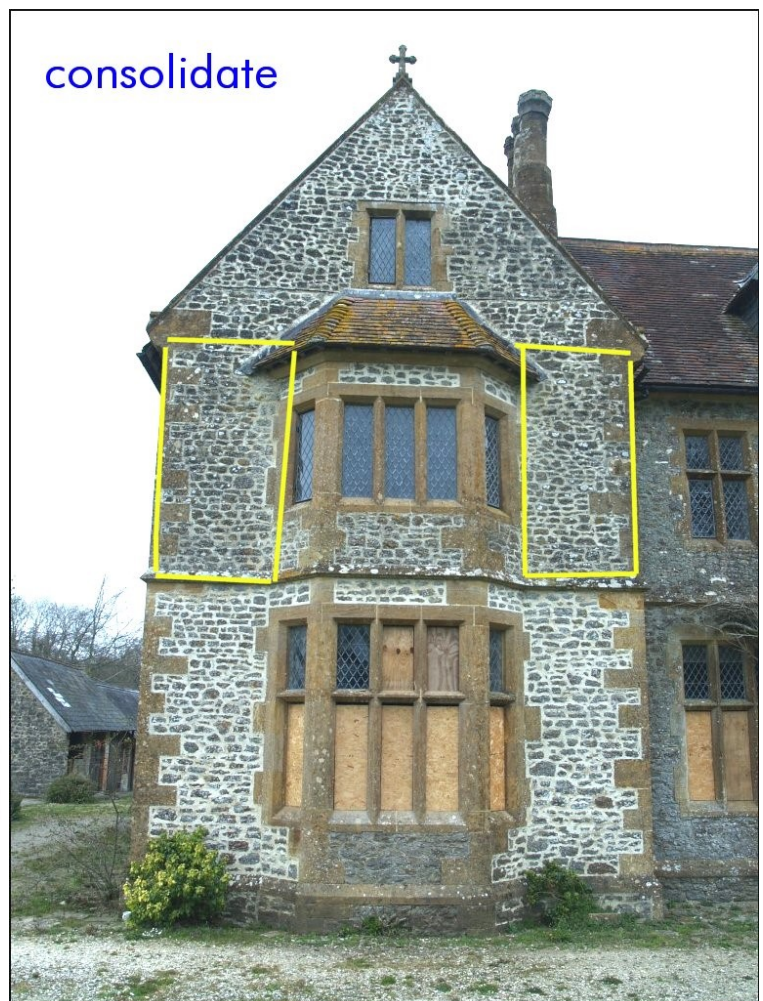
Large areas of the external walls had their outer and inner skins locked together with Cintec consolidation anchors.

Sections of the north wall required substantial stitching where significant cracking had occurred through the lack of lateral restraint at both eaves and first floor level.

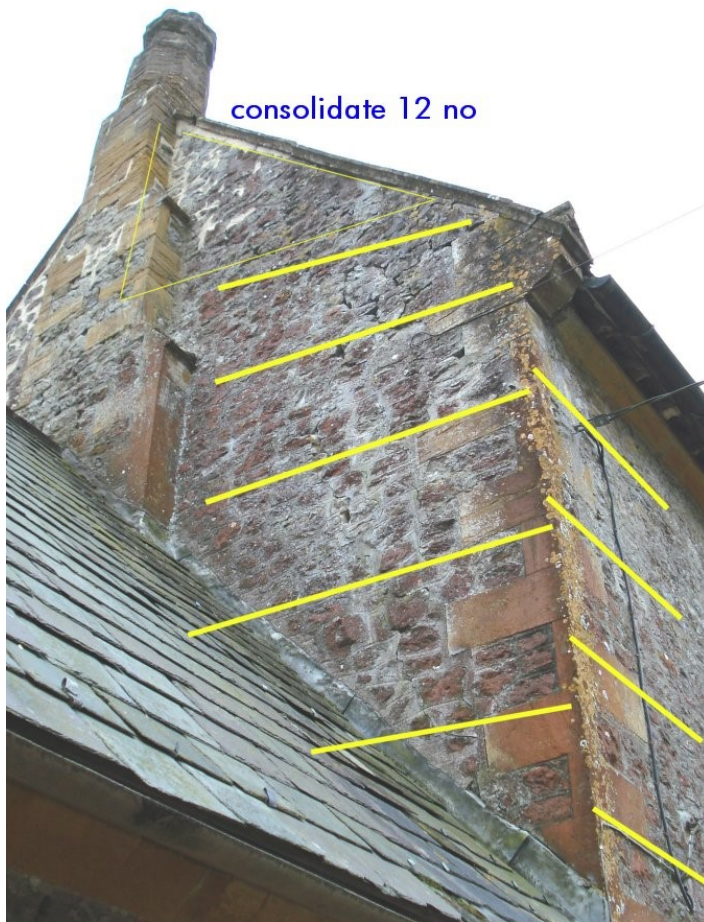
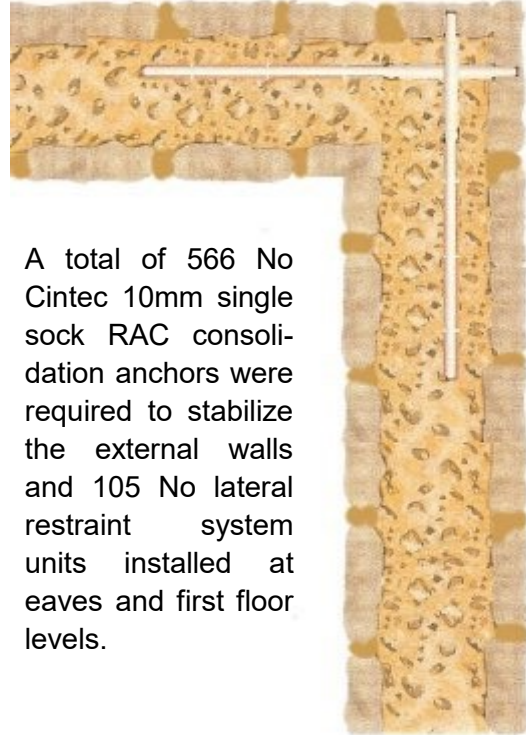
A total of 566 No Cintec 10mm single sock RAC consolidation anchors were required to stabilize the external walls and 105 No lateral restraint system units installed at eaves and first floor levels.

Cintec stitching anchors were used to stabilize walls where cracks had occurred, along with the Cintec lateral restraint systems at eaves and first floor level.

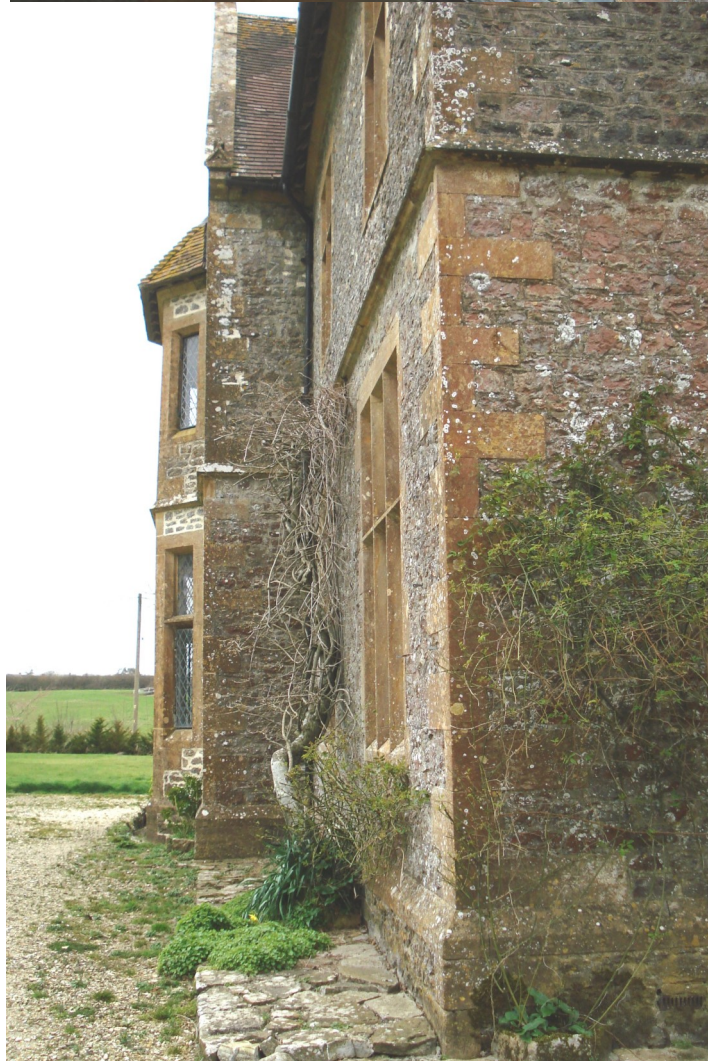
**LATERAL RESTRAINT AT EAVES**

**Structural defects:** The south, west and parts of north walls required consolidation as delamination had occurred. Also lateral restraint was needed to the same walls. At roof level the wall plate bearing the rafters was independent of the ceiling joists, thereby causing spread of the roof, which, in turn, had pushed the external skin of the rubble wall outwards. This wall required consolidation for at least the top metre of its height, and a mechanical connection of the ceiling joists to the outer wall plate and rafters.
