# STONELEIGH ABBEY

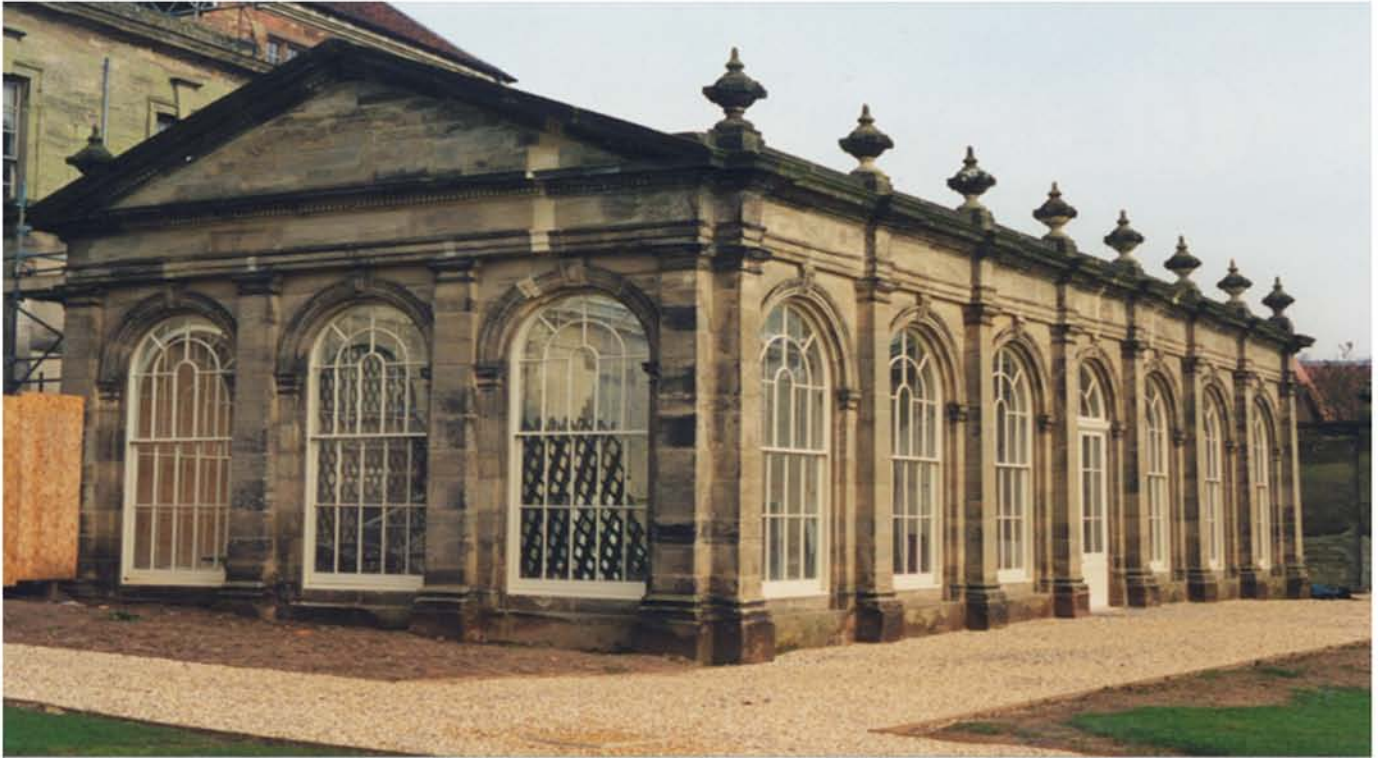
Stoneleigh Abbey This orangery had broken its back both on the short and long sides of the building, which measured some 22 metres by 9 metres, the settlement being caused primarily through inadequate rainwater disposal. The cost of rebuilding the defective parts of the structure would have been enormous. It was therefore decided to keep the deformation in the structure but to stabilise it. The engineer, Don Ascough of Hancock Wheeldon & Ascough, determined to use pre-tensioned Cintec anchors at foundation level and cornice level to hold the curtain walling together. One row of anchors were installed around three sides of the building at foundation level and two rows around all four sides at cornice level. The wall consisted of two skins of ashlar back to back with an irregular void running down the length of the wall. The anchors consisted of 16mm stainless deformed bar in a 76mm dia hole, the 22 metre long ones being in 2 No 11 metre lengths connected on site and pumped from both ends. Once in place the anchors had temporary end plates attached and were tensioned to 10kN prior to grouting. When cured the end plates were removed and the cores replaced and made good.
