# CASE HISTORY

## WORCESTER VIADUCT

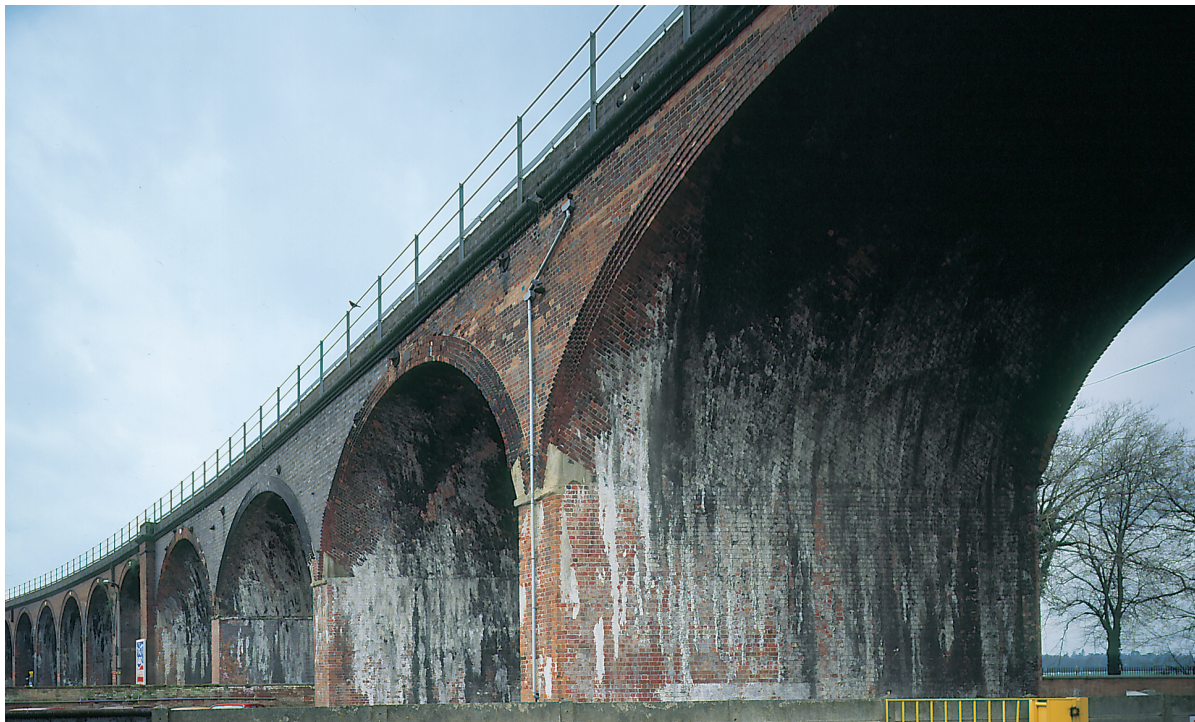
Worcester Viaduct comprises sixty-five brickwork arches rising from approximately two storey height near the railway station to over three storey height as it approaches the river. Lack of proper draining within the arch had led to the spandrel walls being forced away from the intrados arch with longitudinal cracks close to the longitudinal edges of the bridge. Water penetration had contributed to cracking at the springings of some spans and delamination of external parts of some columns. These problems had been exacerbated by weathering, particularly freezing and thawing. Previous efforts to restore the structural integrity were evident, but had proved ineffective.

Transverse 30 x 30 x 3 SHS stainless steel WSA anchors were installed to restore the integrity of the spandrel wall/intrados arch connection at approximately 750mm centre-to-centre and alternate lengths of 2.0m and 2.5m. Stitching anchors were angled across the longitudinal cracks to restore structural integrity and the cracks were then filled. Transverse and diagonal stitching anchors, type RWT, 15 x 15 x 1.5 SHS stainless steel, were installed to restore the strength of the delaminated columns and the cracks filled. Drainage holes were drilled through the intrados and plastic pipes were installed to help relieve the existing water pressure. To date five spans have been renovated using the Cintec system and further spans will be renovated as part of an ongoing maintenance programme.
