## Astley Castle, Warwickshire

## ASTLEY CASTLE – STRUCTURAL REPAIRS SCHEDULE 01 – option 1 (Rev A)

### North End of East Elevation – Proposed

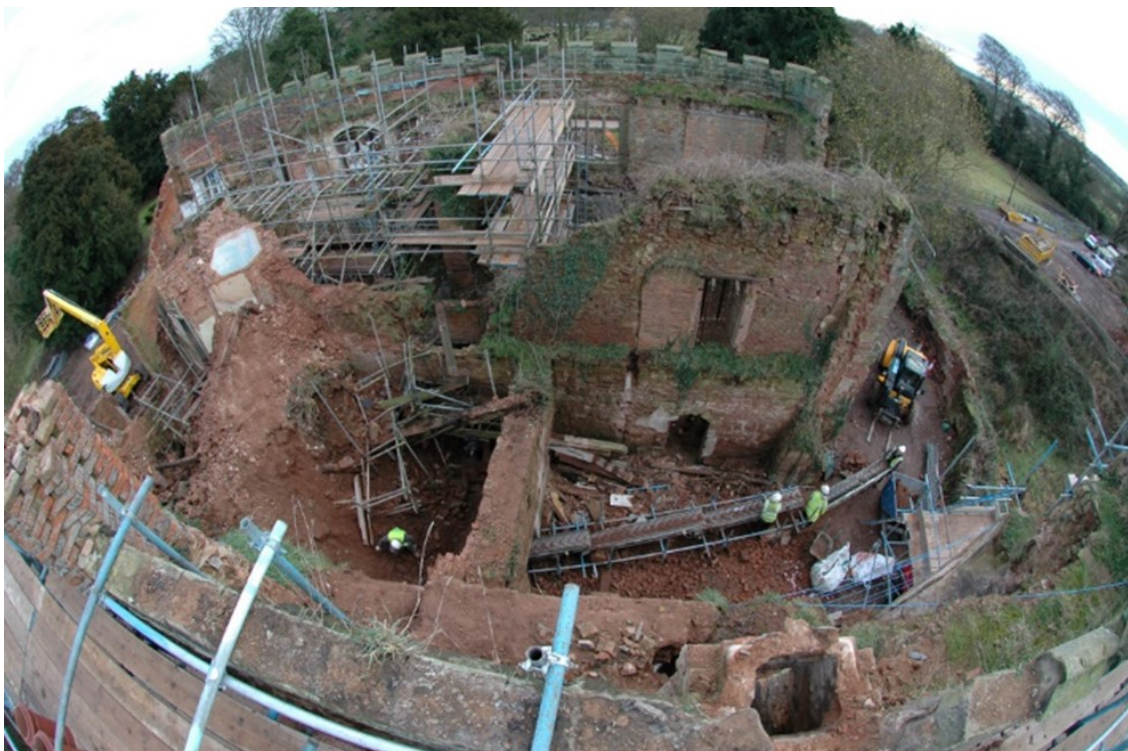
Given the extreme decay and degradation of the masonry this structure was a real challenge. The elements and vegetative growth had taken its toll on the “earth” lime mortar with many areas of missing and loose stones. The main external walls were strengthened longitudinally over the openings and the separating leaves of the wall tied together with consolidation anchors.

Conservation engineers Mann Williams devised an appropriate and sympathetic solution to stabilize the whole structure utilizing the Cintec anchor system.
