# CASE HISTORY

## GEOFFREY HARRIS HOUSE, CROYDON, ENGLAND, U.K.

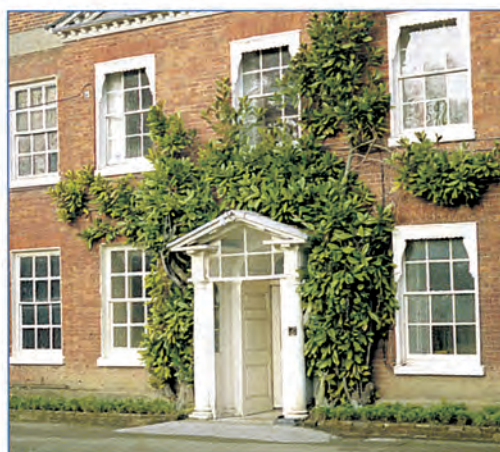
The front elevation of the building itself presented great problems. The facing wall comprised a thin 100 mm skin built without foundations. Of late Victorian age, it was out of plane, cracked and severely out of plumb. Originally built in a straight line, the cavity between the facing wall and the main wall varied from 10 - 75 mm. There are no ties or connection, except for odd pieces of timber.

Soldier arches were provided over the window openings and seen to be displaced or cracked. A survey of the facing wall revealed out of plumb dimensions of 100 to 150 mm. These variations occurred haphazardly over the whole area of the front elevation.

and consulting engineers, Ove Arup & Partners, visited the site on the Company's behalf and, in conjunction with the installers, WT Specialist Contracts, designed a solution using the Cintec System.

It involved using stitching anchors to fix the facing skin to the main wall. The wall was then tied back to a solid internal wall.

The fixings used to anchor back the external wall were 30 mm x 30 mm WSA fixings. The repair solution involved inserting anchors into the external and internal walls at approximately 450 mm centres.
