# Burnton Bridge

Cracking in the barrels due to centrifugal forces meant the imposition of a 5 miles per hour speed limit. Both abseiling and a mast lifter were used to install strengthening anchors.

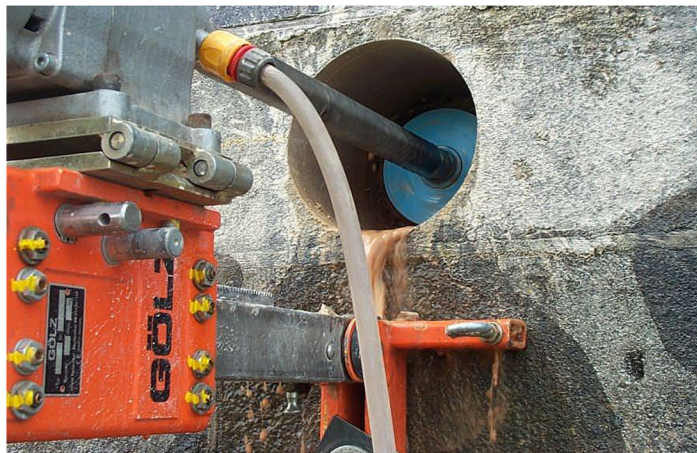
Core Drilling

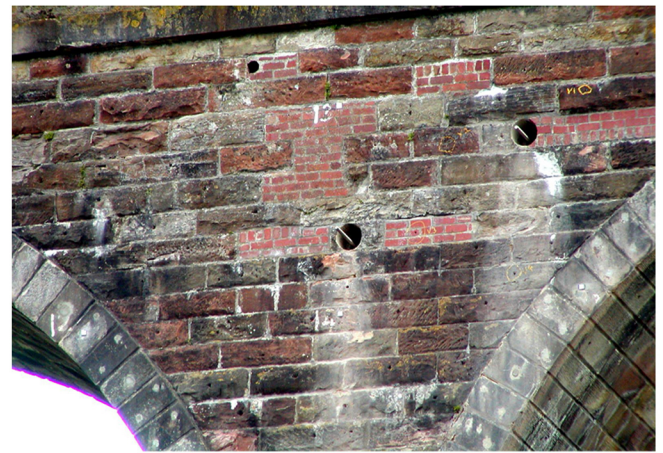
Anchor Placement

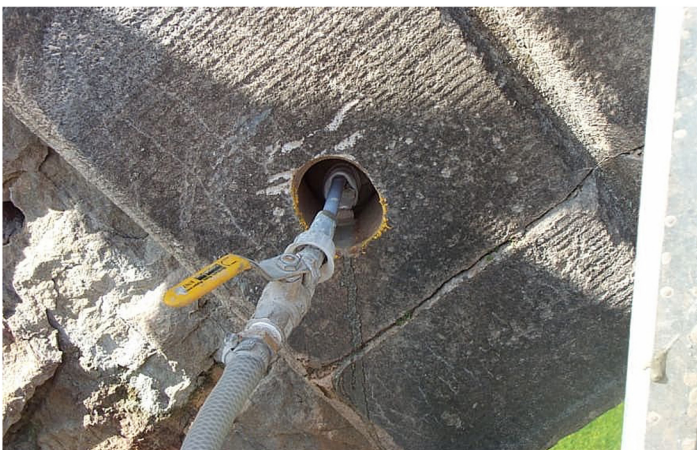
Anchor grout injection

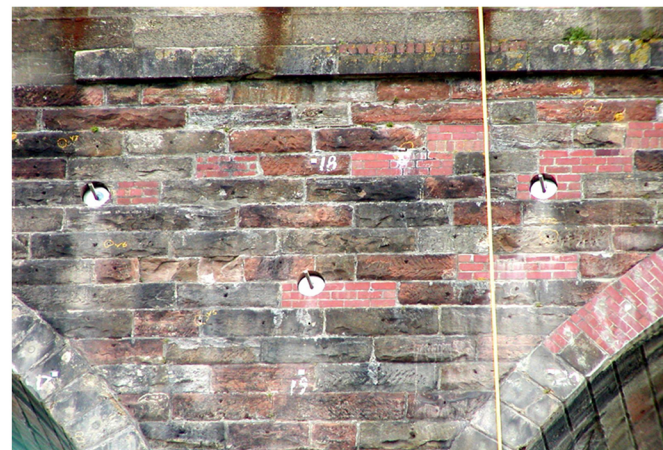
Inflated pipe anchors (Holes subsequently plugged and hidden).
