## HARTPURY TITHE BARN, GLOUCESTERSHIRE

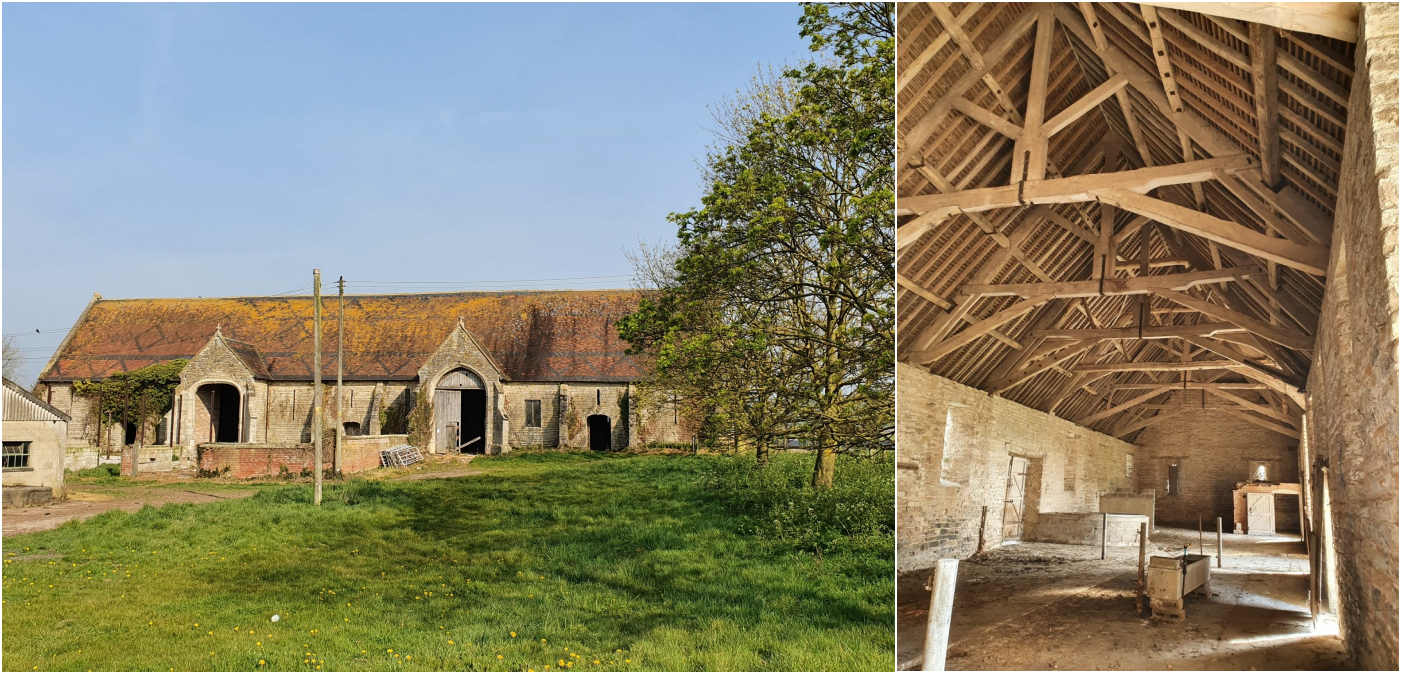
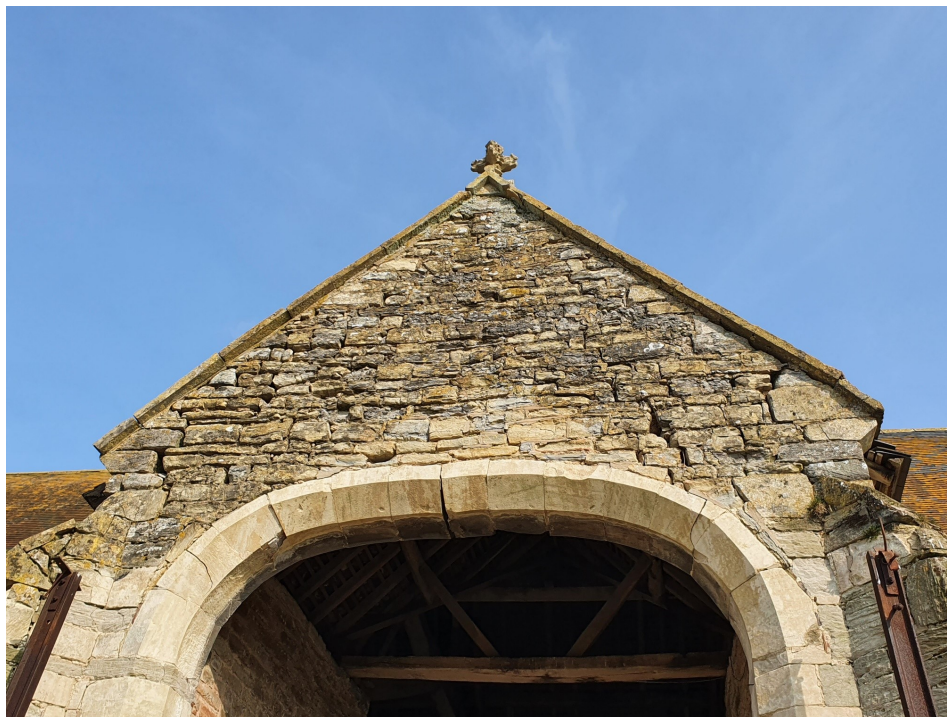
The structural integrity of one of the main arches above one of the main entrances had been compromised by settlement and rotation of left hand return wall due to older alterations to the adjacent ground.

John Topp of structural engineers O'Brien and Price, The Old Bakehouse, Monmouth Rd, Tintern, Monmouthshire, NP16 6SE, undertook a full structural survey and devised a solution using Cintec anchors to eliminate the problems caused by the movement of the wall. The arch was ambitiously flat when originally built centuries ago and the movement of the wall at the springing destabilized the arch to the extent that hinges were formed at the quarter point and the apex.

Temporary timber propping was in place to support the failing arch while the installation of anchors was carried out.

Falcon Structural Repairs Ltd of Bristol drilled and installed two Cintec anchors in excess of 5 metres in length through the failed arch stones using mining barrels which were 55mm in diameter.
